Basin Electric Intertie Noise & Vibration Study and Land Use Assessment

September 2007

Executive Summary and Recommendations

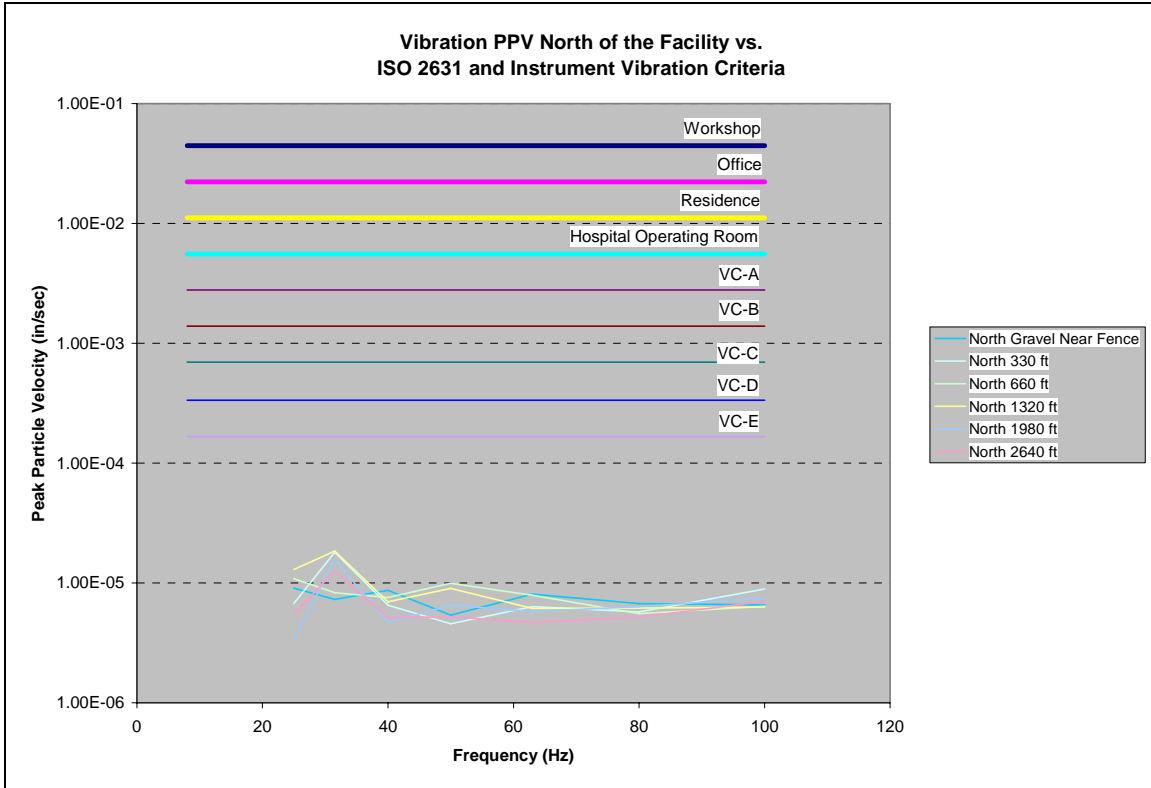
**Figure 6-1
Vibration PPV North of the Facility**

Data in Table 6-1 above show that measured ground-borne vibration levels are below the recommended limit for residential land uses. Figure 6-1 shows the vibration monitoring data measured north of the Facility and compares it to the ISO and VC criteria curves for reference. The data is graphed in PPV.

Data in the table and graph shows that vibration levels are significantly below the criteria curve for acceptable vibration levels for residential land use to the North of the Facility. Given the almost three orders of magnitude difference between the measured maximum values and the HDR limit (ISO residential limit), it is unlikely that the observed frequency spikes at 31.5 Hz would be perceived by anyone standing outdoors at these locations.

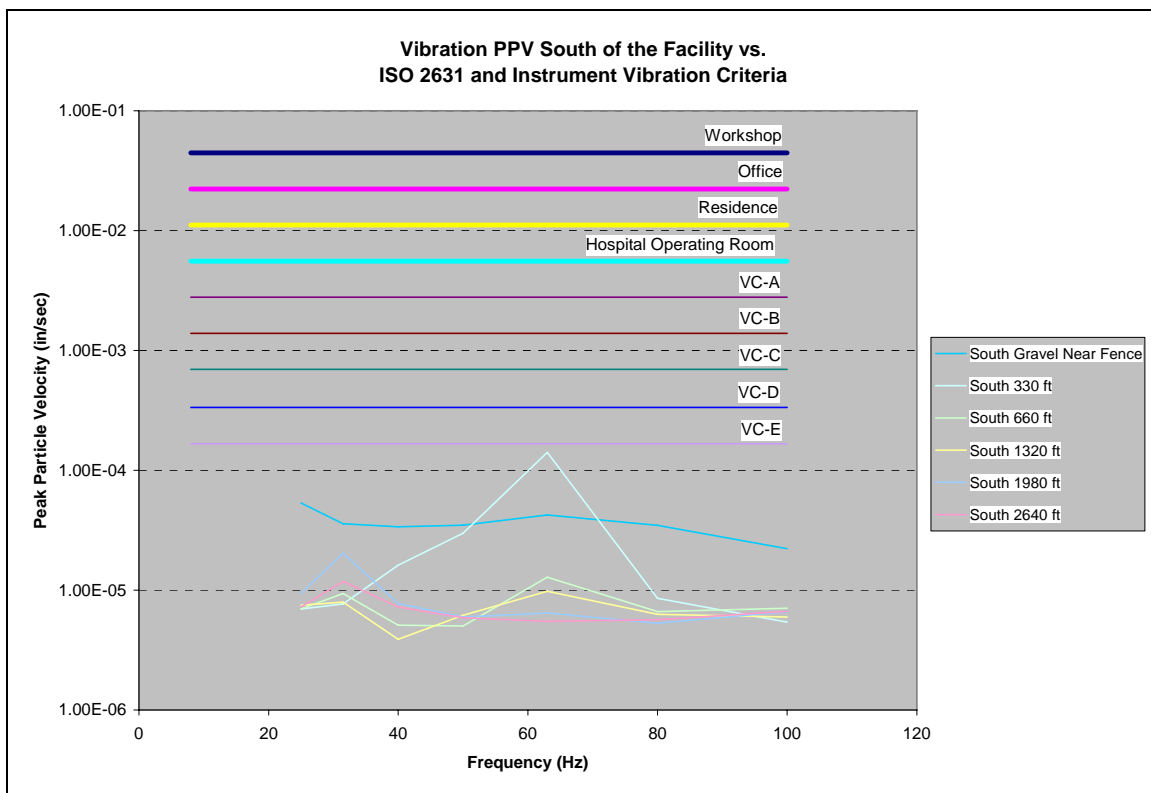
Figure 6-2
Vibration PPV South of the Facility

Data in Table 6-2 show that measured ground-borne vibration levels are below the recommended limit for residential land uses. Figure 6-2 shows the vibration monitoring data measured south of the Facility and compares it to the ISO and VC criteria curves for reference. The data is graphed in PPV.

Data in the table and graph shows that vibration levels are significantly below the criteria curve for acceptable vibration levels for residential land use to the South of the Facility. While there are frequency spikes seen at all six locations, approximately two orders of magnitude difference exists between the HDR limit and the measured maximum value, as such, it is unlikely that the observed frequency spikes would be perceived by anyone

standing on the ground at these locations. The spike at 63 Hz in data collected at the 330-foot South location is assumed to reflect the 60-cycle hum typically associated with electrical circuits. Interestingly, this spike is not present at the zero feet measurement, and it is one order of magnitude lower at the 660-foot measurement location. The spike is visible again at 1320 feet, although it is somewhat lower in magnitude than at the 660-foot measurement. The magnitude of the 63 Hz vibration velocity at 330 feet in this location suggests there might be subsurface condition that is conducive to vibration propagation; however this is a speculative statement. Future land uses that are extremely sensitive to vibration (such as nano-scale technology applications) evaluate the suitability of this location for the proposed application.

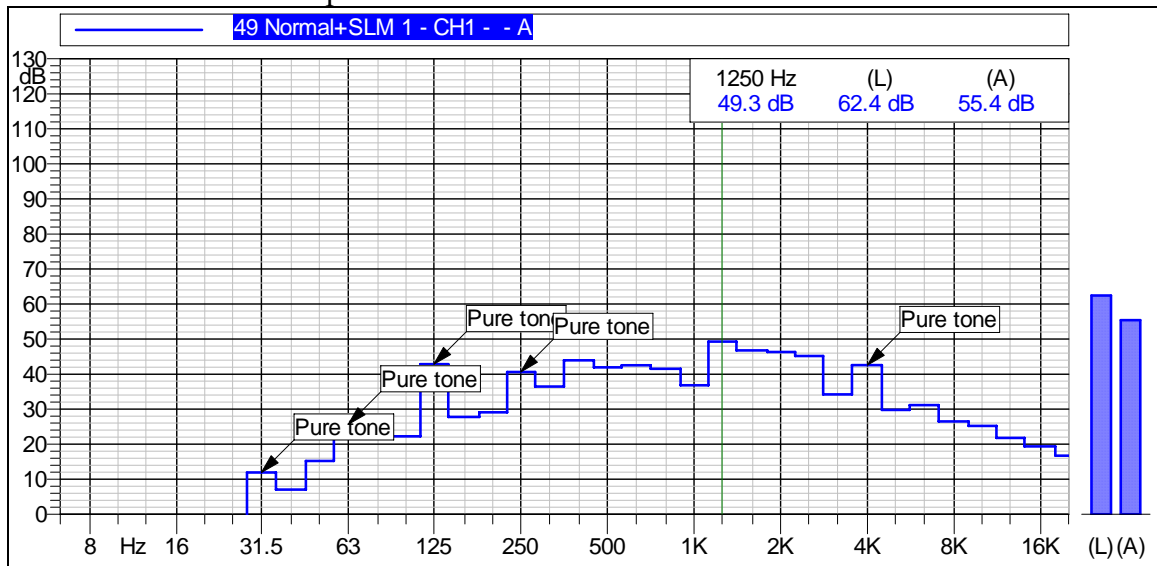
Figure A-1
Graph of Noise Levels Measured 0-ft North

This figure shows that the Leq was 55.4 dBA and that the maximum sound pressure level of 49.3 dBA was measured at 1250 Hz. A number of pure tones appear on this graph – first in the octave band centers at 31.5, 63, 125, and 250 Hz. An additional pure tone appears at 4 kHz. These are all harmonics of the typical 60 Hz hum associated with high voltage transformers; a distinct hum is clearly audible at this location. Pure tones at levels below 30 dBA may not be audible to the average person, particularly at frequencies below 80 Hz.

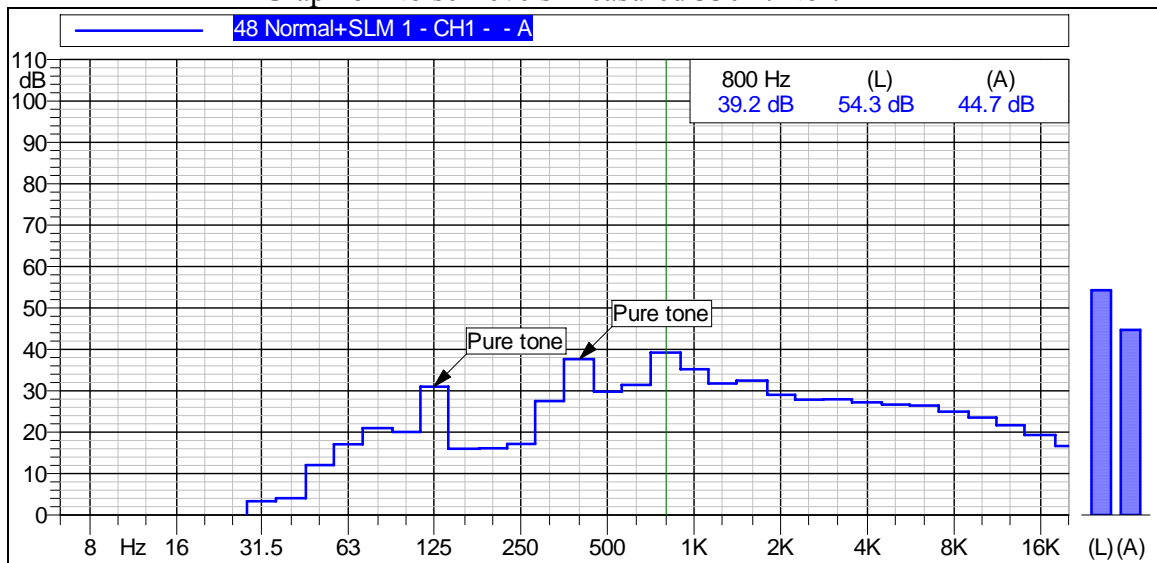
This figure shows that the Leq was 44.7 dBA and that the maximum sound pressure level of 39.2 dBA was measured at 800 Hz. Two pure tones appear on this graph – first at the octave band center at 125 Hz and again at 400 Hz. There also appears to be something close to a pure tone at 800 Hz. In the absence of background noises that can mask these tones, the tones may be considered annoying to some people.

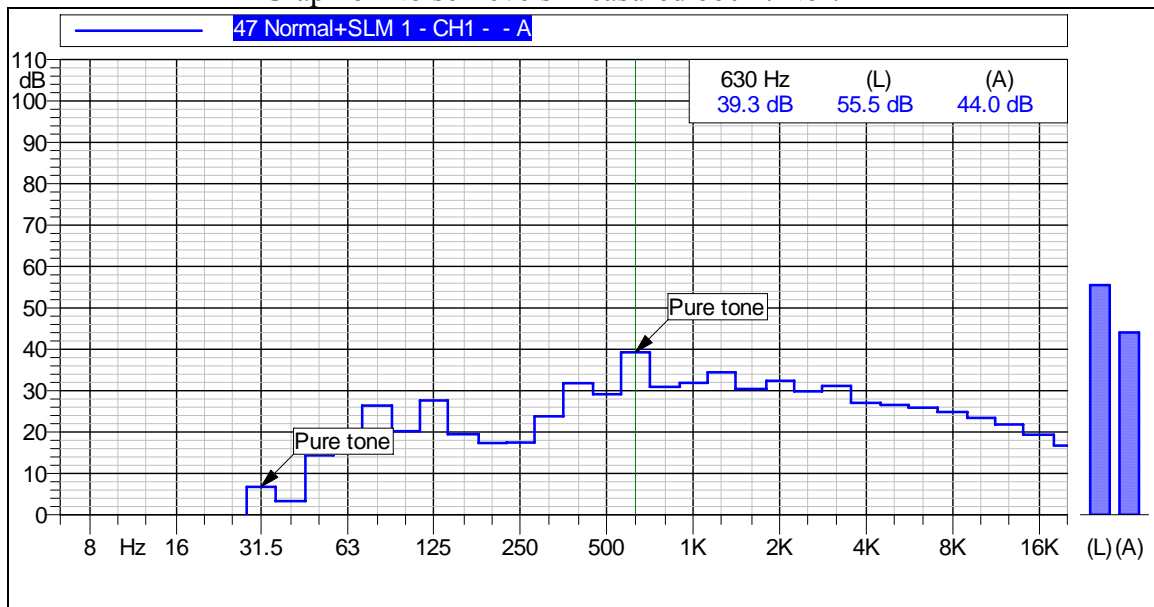
This figure shows that the Leq was 44 dBA and that the maximum sound pressure level of 39.3 dBA was measured at 630 Hz. Two pure tones appear on this graph – first at 31.5 Hz and again at 630 Hz. There also appears to be noise that approaches the definition of a pure tone at 80 Hz. In the absence of background noises that can mask these tones, the tones may be considered annoying to some people. Pure tones at levels below 30 dBA may not be audible to the average person, particularly at frequencies below 80 Hz.

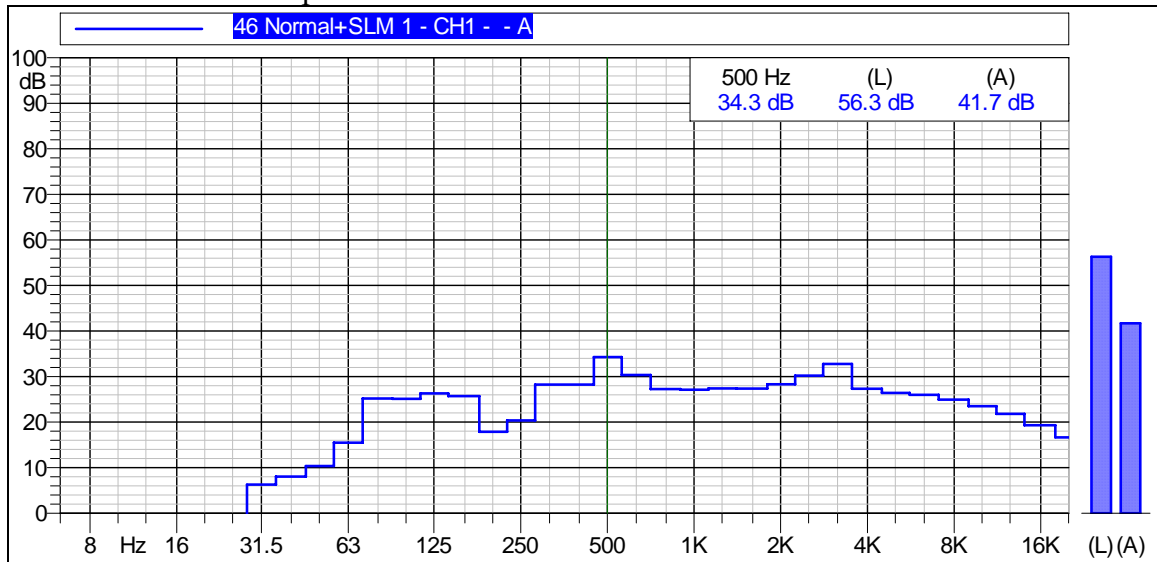
This figure shows that the Leq was 41.7 dBA and that the maximum sound pressure level of 34.3 dBA was measured at 500 Hz. No pure tones appear on this graph, though there is a peak at the 500 Hz octave band center. In the absence of background noises that can mask these tones, the tones may be considered annoying to some people.

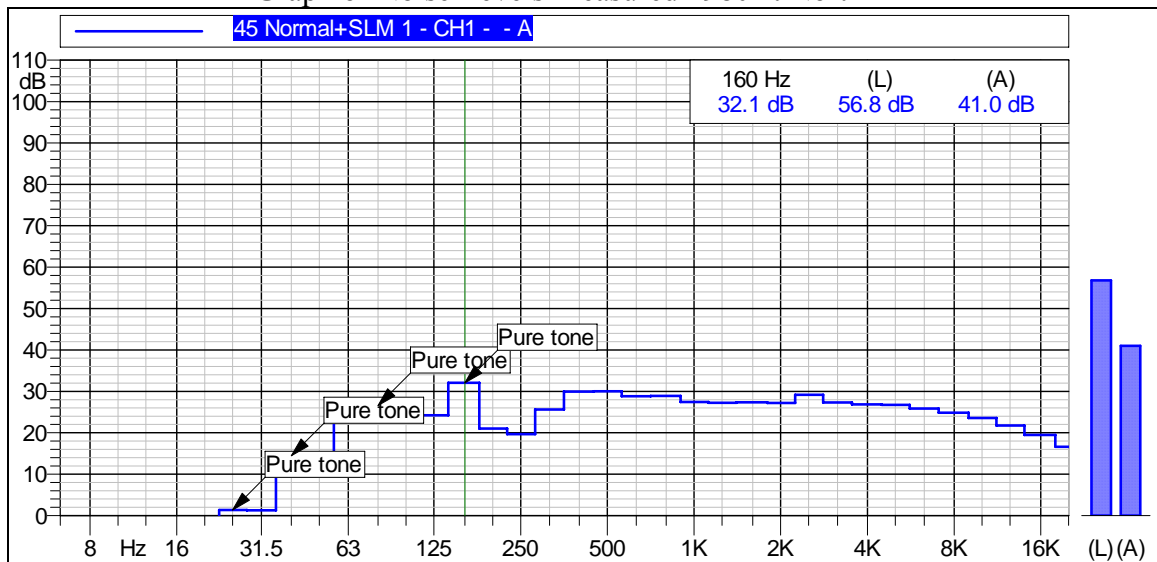
This figure shows that the Leq was 41 dBA and that the maximum sound pressure level of 32.1 dBA was measured at 160 Hz. Four pure tones appear on this graph – at 25, 40, 80, and 160 Hz. In the absence of background noises that can mask these tones, the tones may be considered annoying to some people. Pure tones at levels below 30 dBA may not be audible to the average person, particularly at frequencies below 80 Hz.

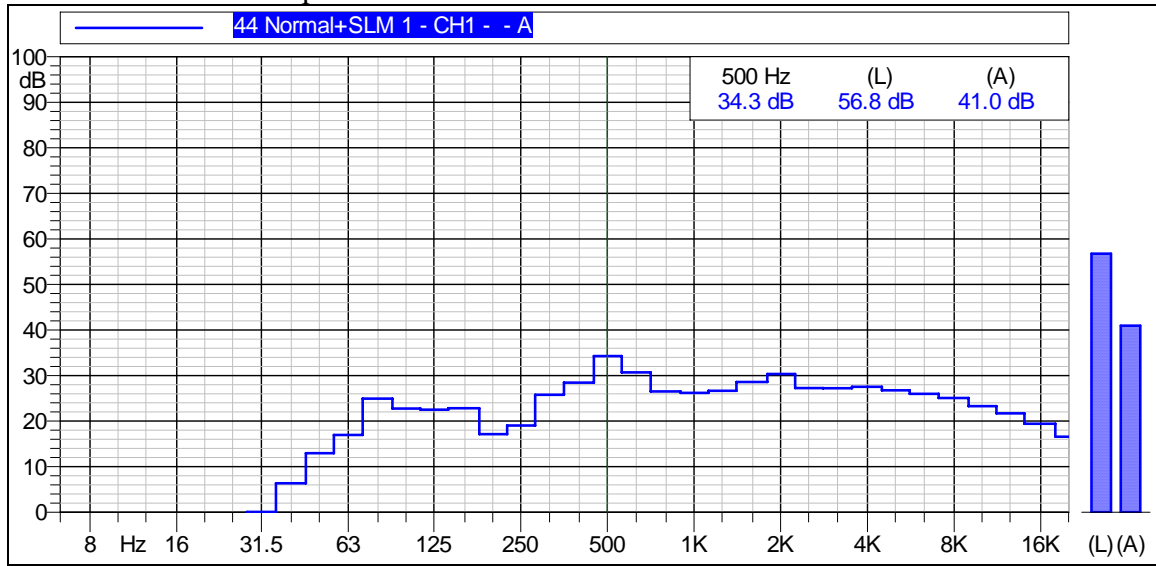
This figure shows that the Leq was 41 dBA and that the maximum sound pressure level of 34.3 dBA was measured at 500 Hz. No pure tones appear on this graph, though there is a peak at the 500 Hz octave band center. In the absence of background noises that can mask these tones, the tones may be considered annoying to some people

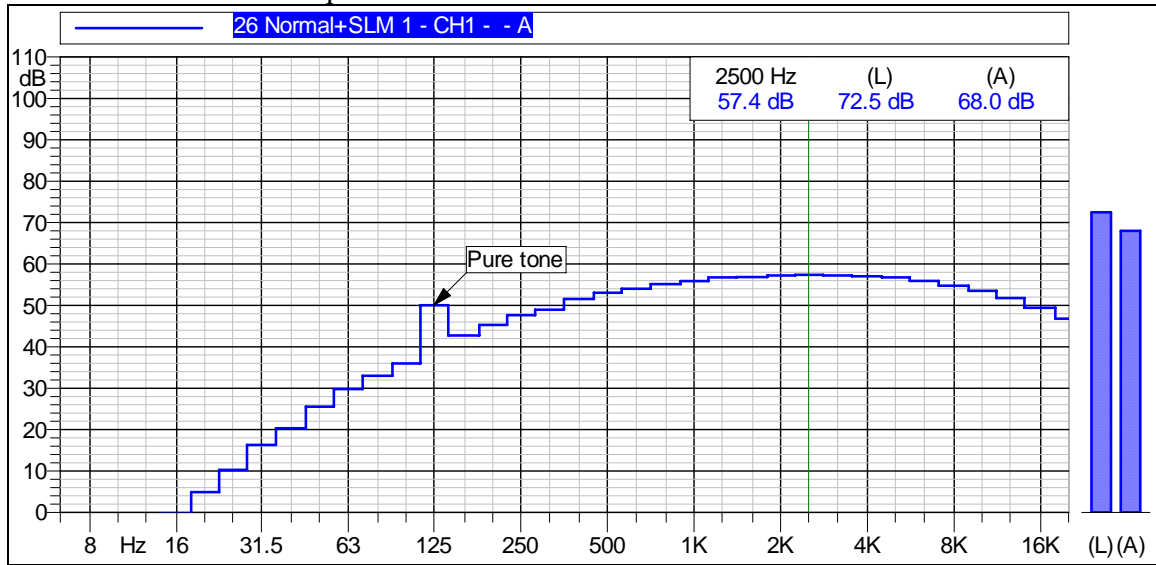
This figure shows that the Leq was 68 dBA and that the maximum sound pressure level of 57.4 dBA was measured at 2500 Hz. A pure tone appears on this graph, at 125 Hz. In the absence of background noises that can mask these tones, the tone may be considered annoying to some people.

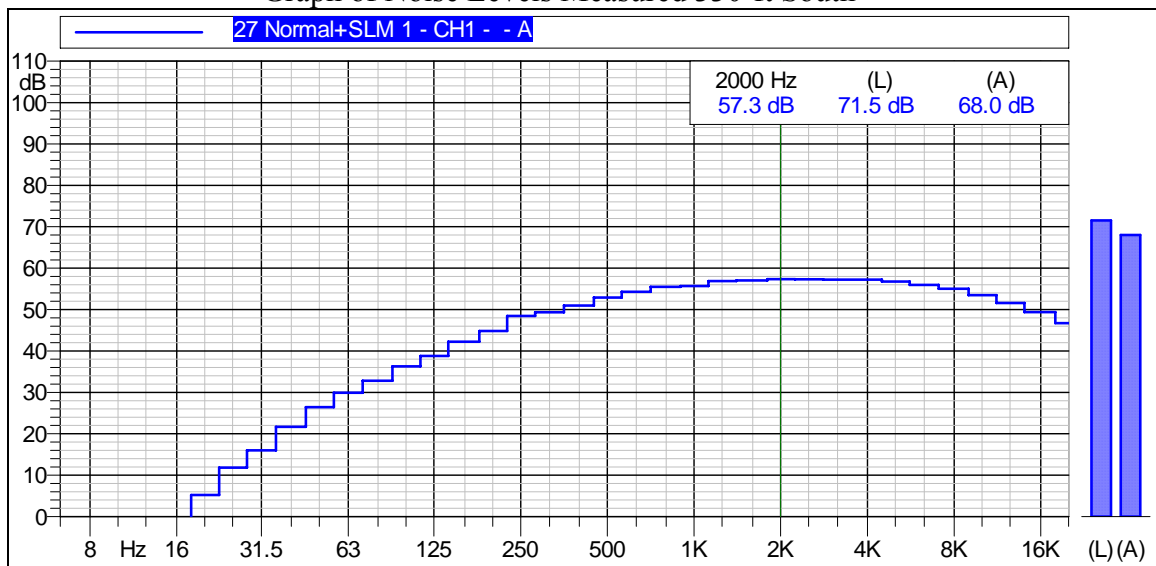
This figure shows that the Leq was 68 dBA and that the maximum sound pressure level of 57.3 dBA was measured at 2000 Hz. No pure tones appear on this graph.

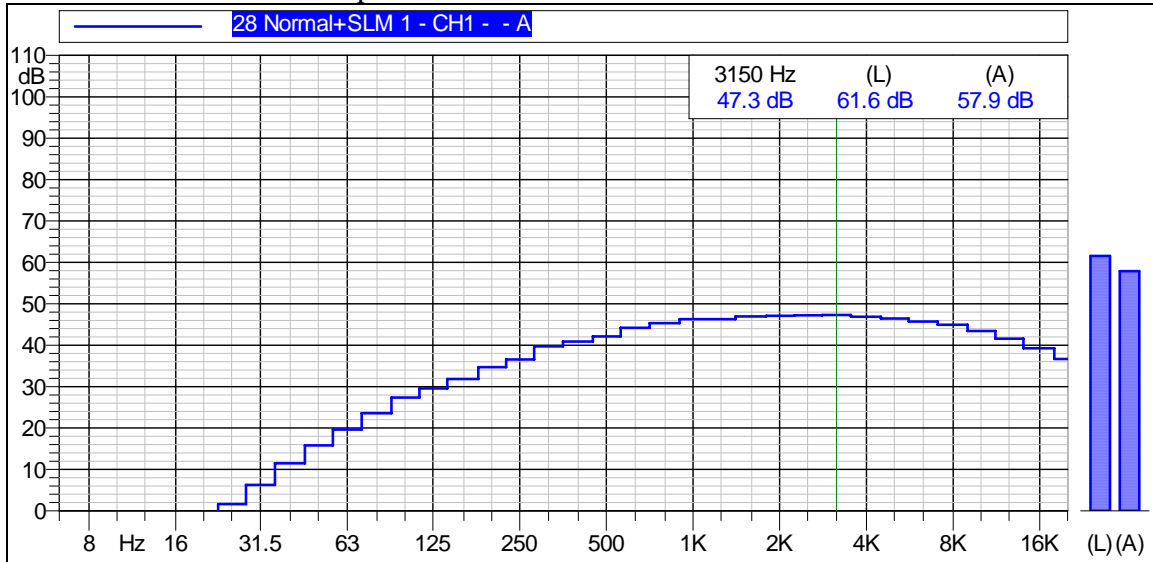
This figure shows that the Leq was 57.9 dBA and that the maximum sound pressure level of 47.3 dBA was measured at 3150 Hz. No pure tones appear on this graph.

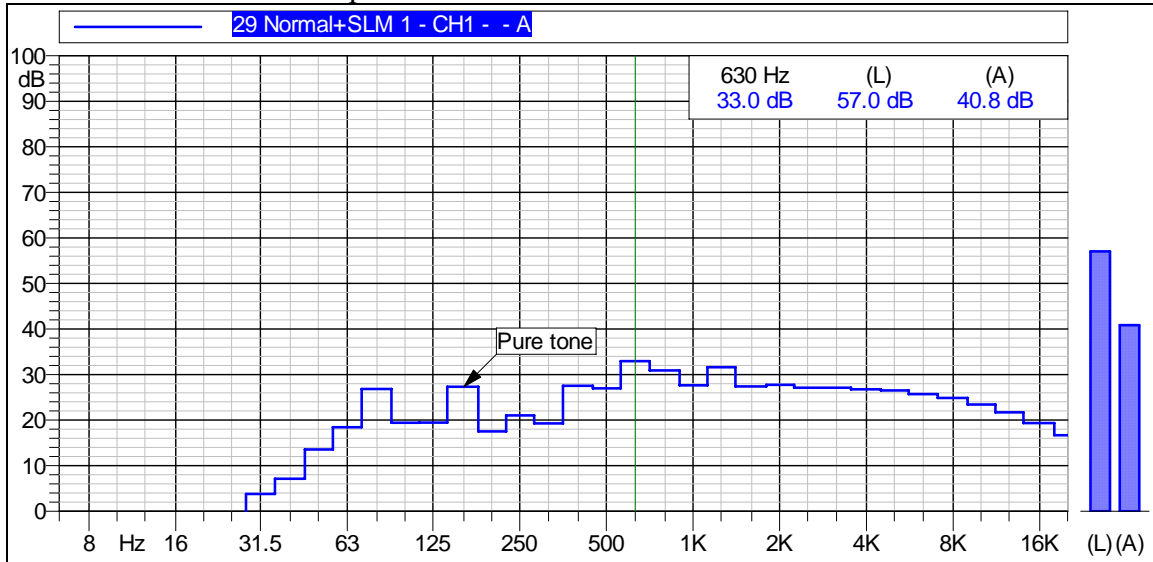
This figure shows that the Leq was 40.8 dBA and that the maximum sound pressure level of 33 dBA was measured at 630 Hz. A pure tone appears on this graph, at 160 Hz. There is also a peak at the 80 Hz octave band center. In the absence of background noises that can mask these tones, the tone may be considered annoying to some people. Pure tones at levels below 30 dBA may not be audible to the average person, particularly at frequencies below 80 Hz.

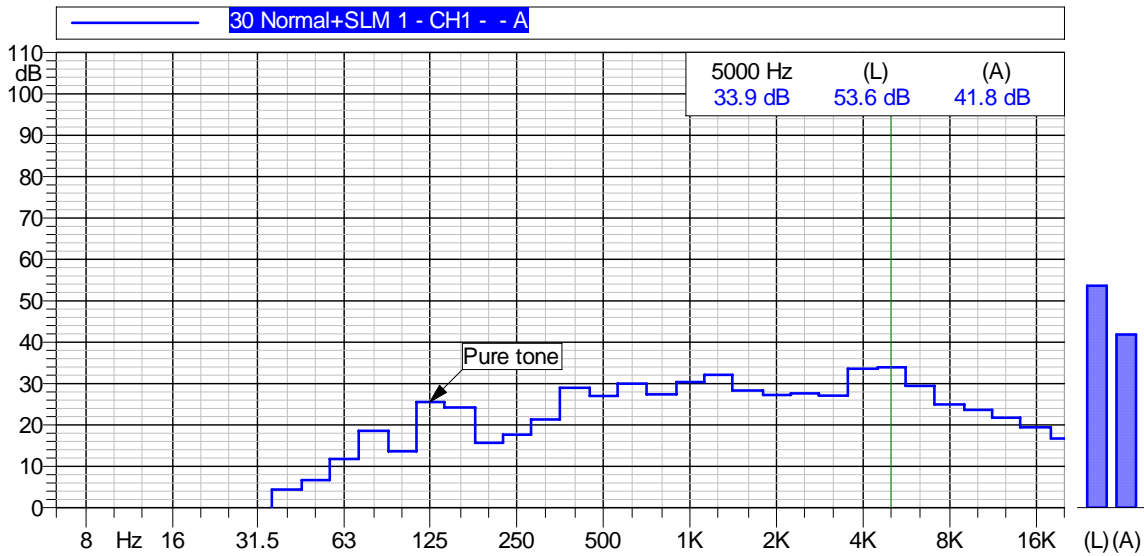
This figure shows that the Leq was 42 dBA and that the maximum sound pressure level of 33.9 dBA was measured at 5000 Hz. The data processing software identified a pure tone at 125 Hz. There is also smaller peak at the 80 Hz octave band center. In the absence of background noises that can mask these tones, the tones may be considered annoying to some people. Pure tones at levels below 30 dBA may not be audible to the average person, particularly at frequencies below 80 Hz.

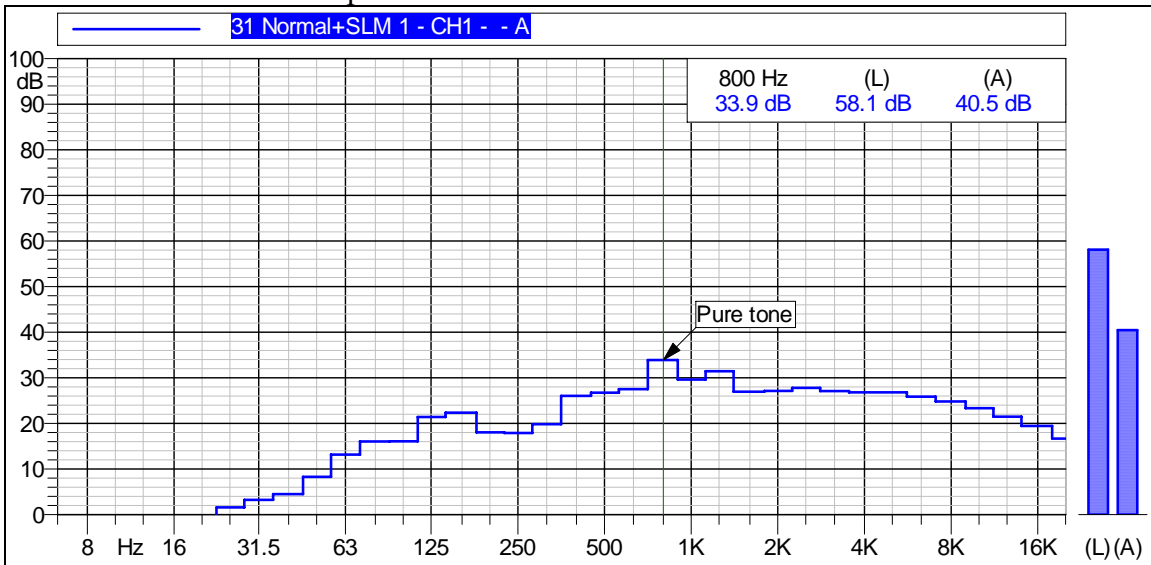
This figure shows that the Leq was 41 dBA and that the maximum sound pressure level of 33.9 dBA was measured at 800 Hz. A pure tone appears on this graph, at 800 Hz.

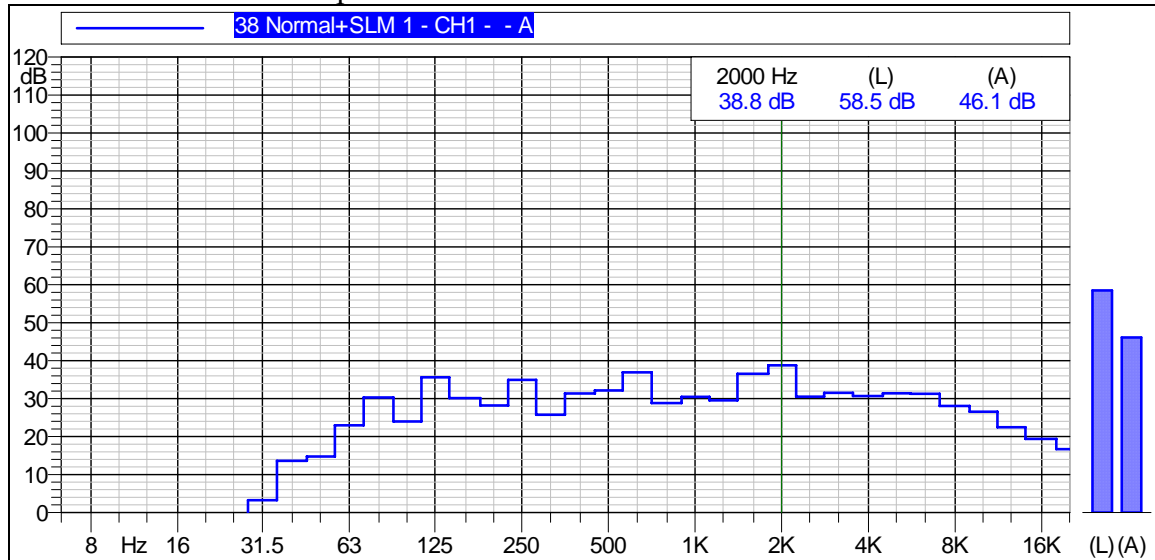
This figure shows that the Leq was 46 dBA and that the maximum sound pressure level of 38.8 dBA was measured at 2000 Hz. Pure tones do not appear on this graph. However, there are elevated levels at 80, 125, 250, 630 Hz. In the absence of background noises that can mask these tones, the tones may be considered annoying to some people.

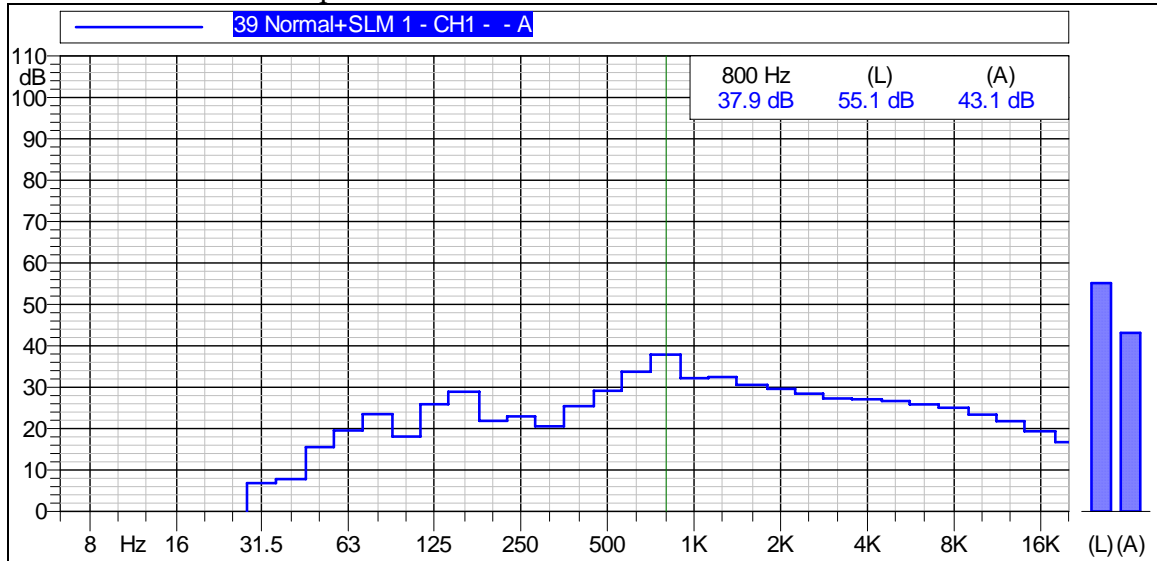
This figure shows that the Leq was 43.1 dBA and that the maximum sound pressure level of 37.9 dBA was measured at 800 Hz. No pure tones appear on this graph. However there are peaks at 80, between 125 and 160, and at 800 Hz. In the absence of background noises that can mask these tones, the tones may be considered annoying to some people. Pure tones at levels below 30 dBA may not be audible to the average person, particularly at frequencies below 80 Hz.

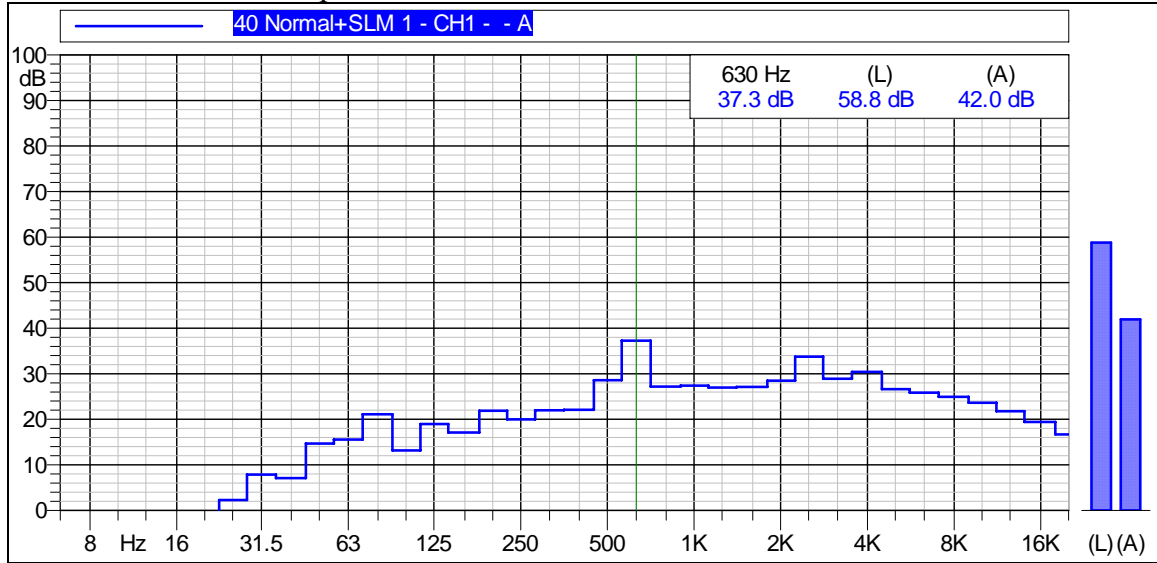
This figure shows that the Leq was 42 dBA and that the maximum sound pressure level of 37.3 dBA was measured at 630 Hz. No pure tones appear on this graph. However elevated levels at 80, 630, and 2500 Hz octave band centers could reach pure tone levels under different operational and meteorological circumstances. In the absence of background noises that can mask these tones, the tones may be considered annoying to some people. Pure tones at levels below 30 dBA may not be audible to the average person, particularly at frequencies below 80 Hz.

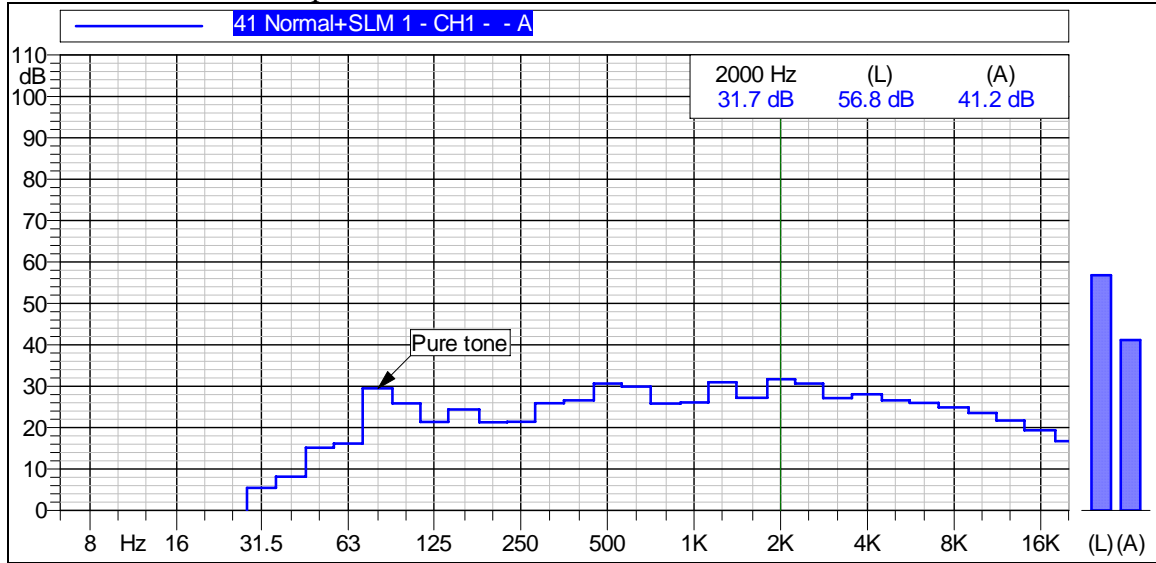
This figure shows that the Leq was 41.2 dBA and that the maximum sound pressure level of 31.7 BA was measured at 2000 Hz. A pure tone appears on this graph, at 80 Hz. In the absence of background noises that can mask these tones, the tones may be considered annoying to some people. Pure tones at levels below 30 dBA may not be audible to the average person, particularly at frequencies below 80 Hz.

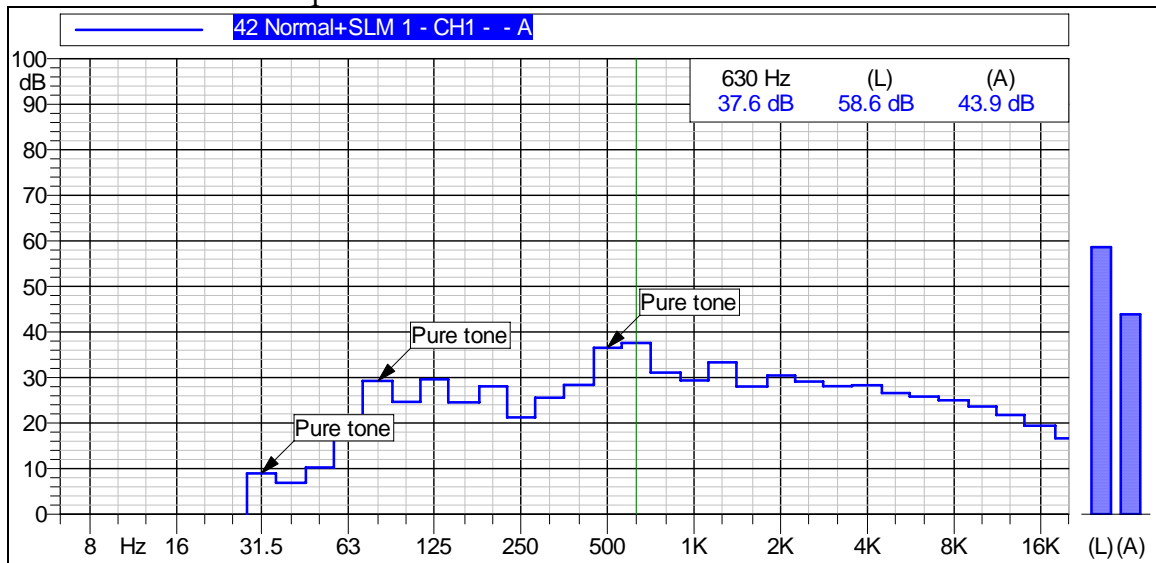
This figure shows that the Leq was 43.9 dBA and that the maximum sound pressure level of 37.6 dBA was measured at 630 Hz. Pure tones appear on this graph, at 31.5, 80, and 800 Hz. There are also peaks at 125, 200, and 1250 Hz octave band centers. In the absence of background noises that can mask these tones, the tones may be considered annoying to some people. Pure tones at levels below 30 dBA may not be audible to the average person, particularly at frequencies below 80 Hz.

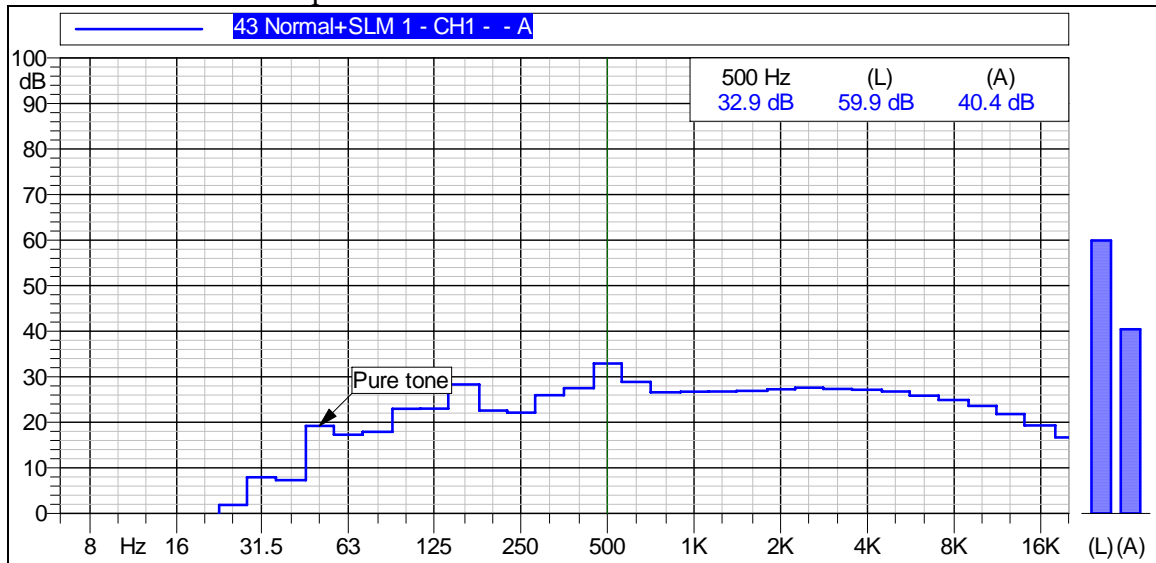
This figure shows that the Leq was 40 dBA and that the maximum sound pressure level of 32.9 dBA was measured at 500 Hz. A pure tone appears on this graph at 50 Hz though there is a peak at the 160 Hz octave band center. In the absence of background noises that can mask these tones, the tones may be considered annoying to some people. Pure tones at levels below 30 dBA may not be audible to the average person, particularly at frequencies below 80 Hz.

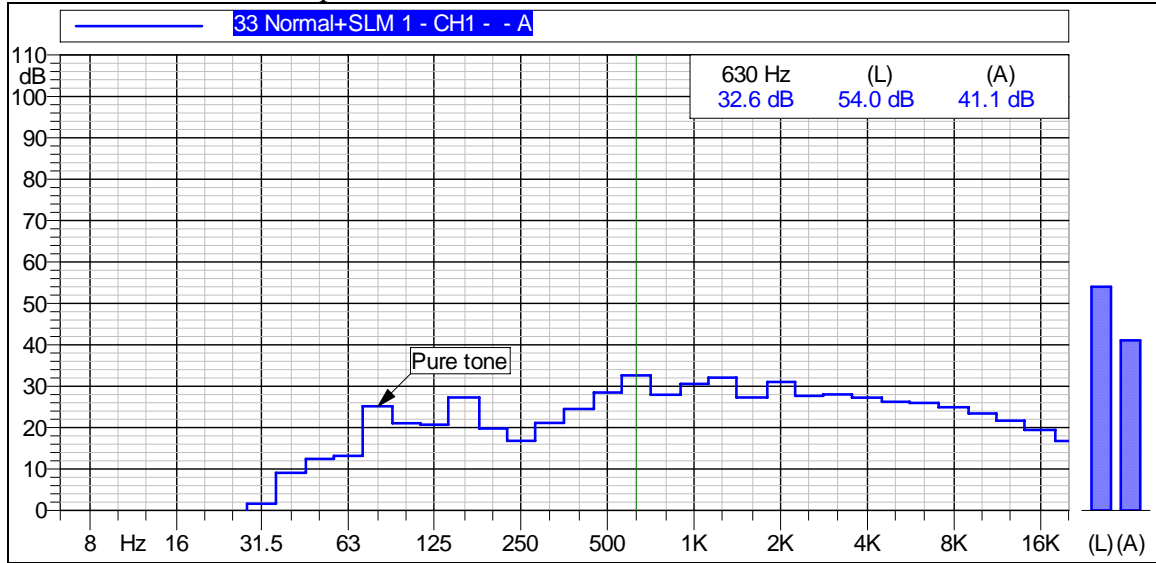
This figure shows that the Leq was 41 dBA and that the maximum sound pressure level of 32.6 dBA was measured at 630 Hz. A pure tone appears on this graph, at 80 Hz though there is a peak at the 160 Hz octave band center. In the absence of background noises that can mask these tones, the tones may be considered annoying to some people. Pure tones at levels below 30 dBA may not be audible to the average person, particularly at frequencies below 80 Hz.

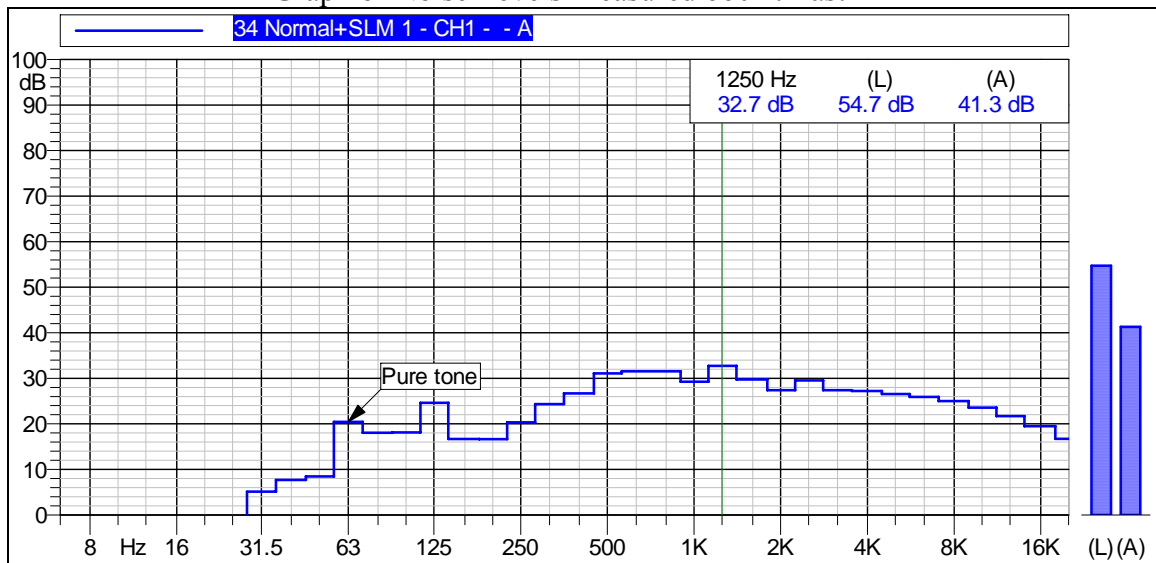
This figure shows that the Leq was 41 dBA and that the maximum sound pressure level of 32.7 dBA was measured at 1250 Hz. A pure tone appears on this graph, at 63 Hz though there is a peak at the 125 Hz octave band center. In the absence of background noises that can mask these tones, the tones may be considered annoying to some people. Pure tones at levels below 30 dBA may not be audible to the average person, particularly at frequencies below 80 Hz.

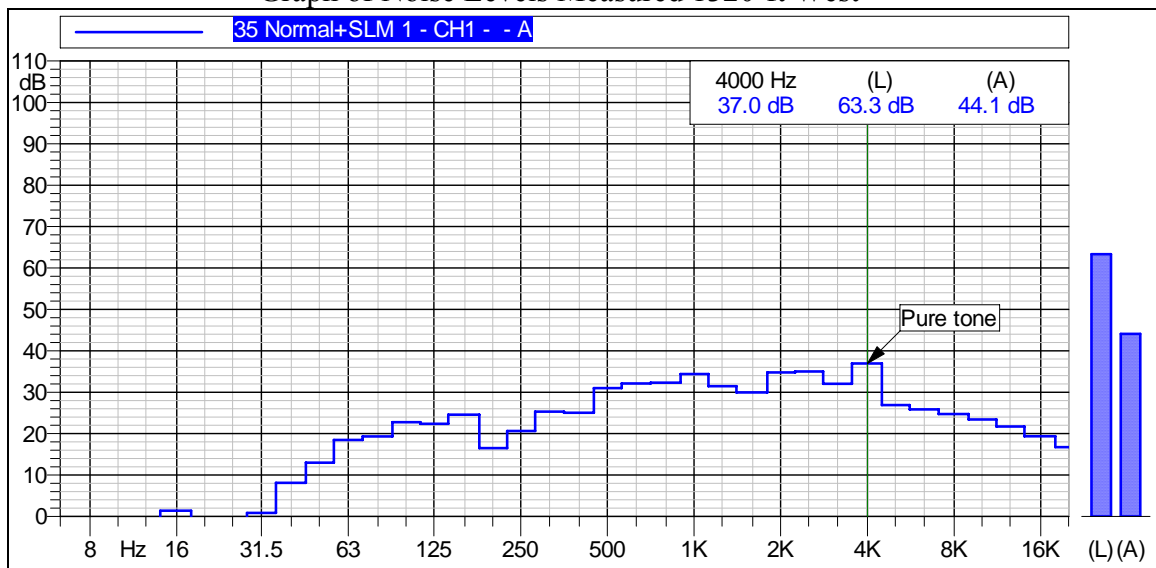
This figure shows that the Leq was 41 dBA and that the maximum sound pressure level of 37 dBA was measured at 4000 Hz. A pure tone appears on this graph, at 4000 Hz. In the absence of background noises that can mask this tone, the tone may be considered annoying to some people. Pure tones at levels below 30 dBA may not be audible to the average person, particularly at frequencies below 80 Hz.

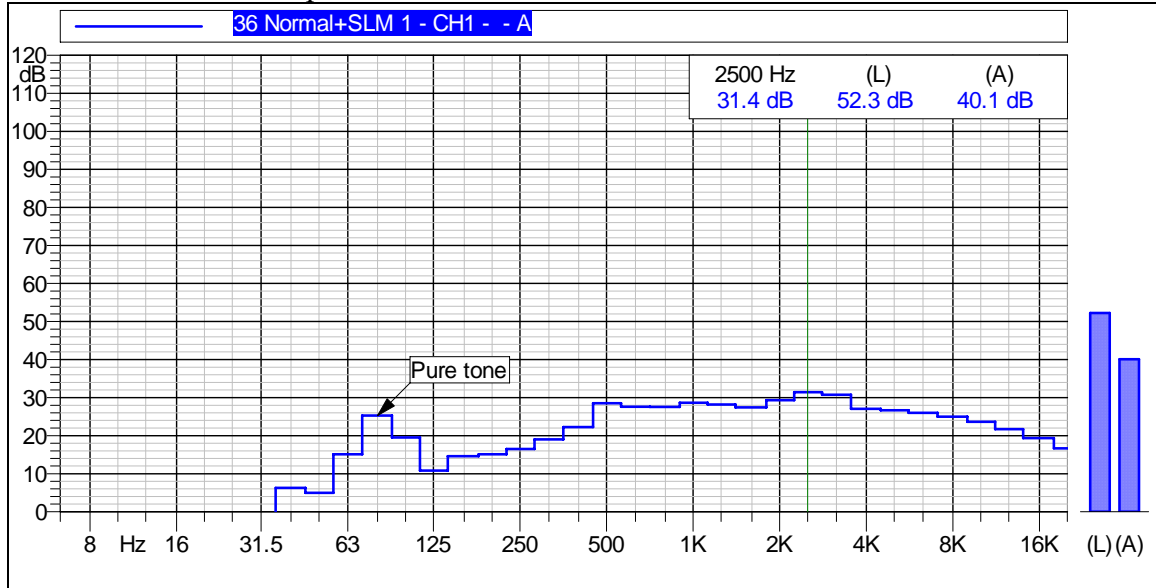
This figure shows that the Leq was 41 dBA and that the maximum sound pressure level of 31.4 dBA was measured at 2500 Hz. A pure tone appears on this graph at 80 Hz. In the absence of background noises that can mask this tone, the tone may be considered annoying to some people. Pure tones at levels below 30 dBA may not be audible to the average person, particularly at frequencies below 80 Hz.

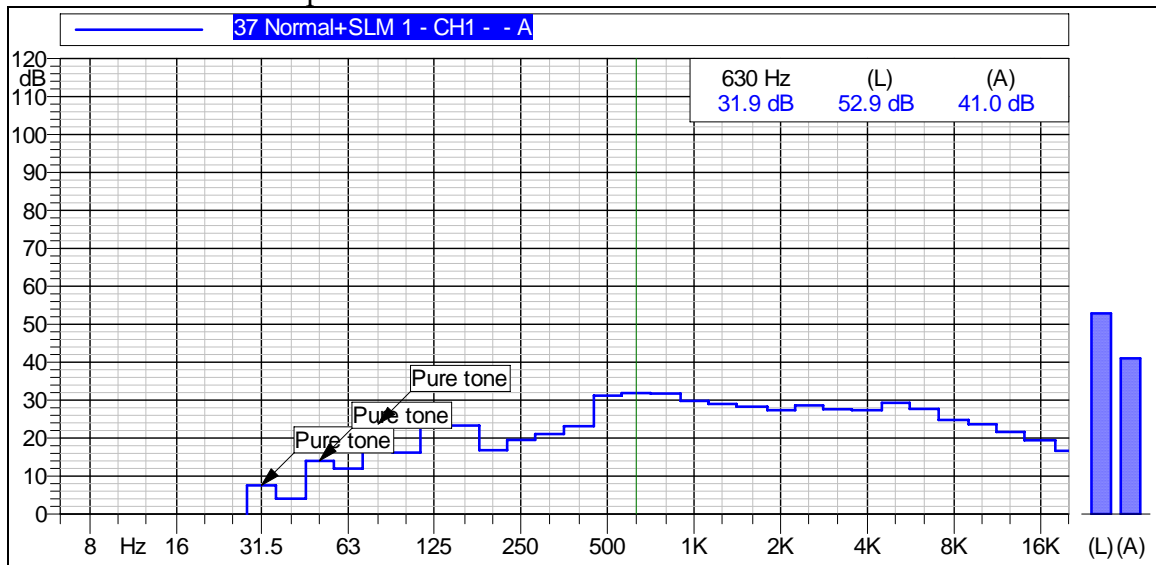
This figure shows that the Leq was 41 dBA and that the maximum sound pressure level of 31.9 dBA was measured at 630 Hz. Pure tones appear on this graph, at 31.5, 50, and 80 Hz though there are peaks at the 125 and 160 Hz octave band centers. In the absence of background noises that can mask these tones, the tones may be considered annoying to some people. Pure tones at levels below 30 dBA may not be audible to the average person, particularly at frequencies below 80 Hz.

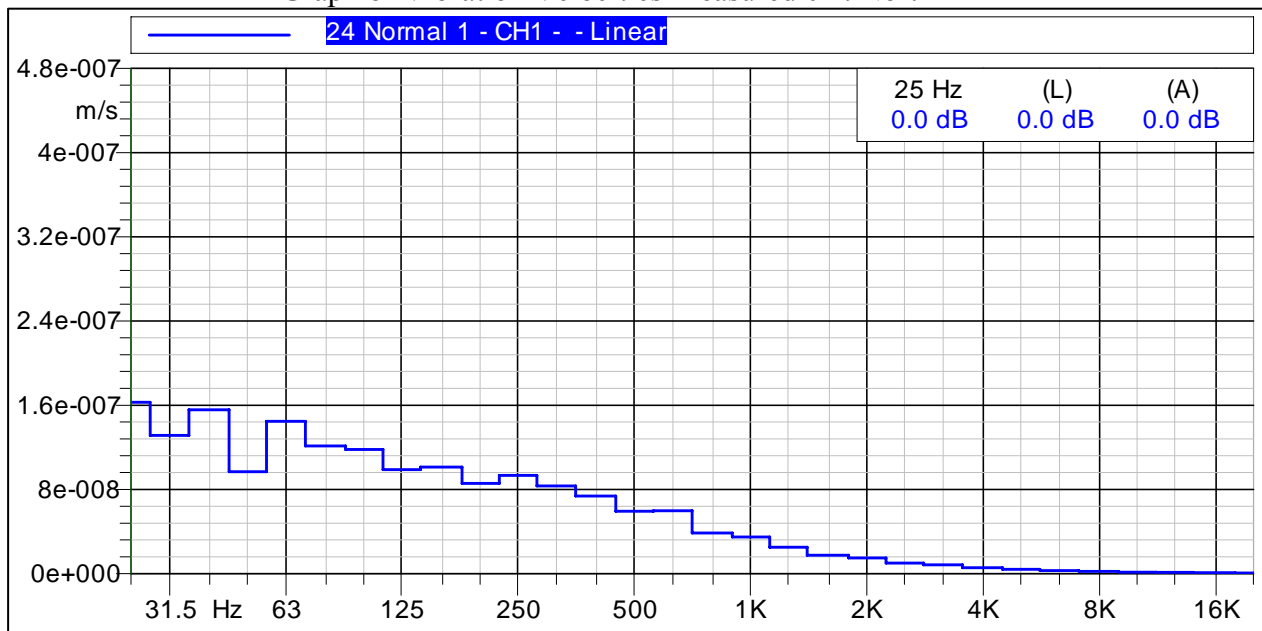
This figure shows that the maximum velocity occurred at 25 Hz. There are no frequency spikes that appear on this graph.

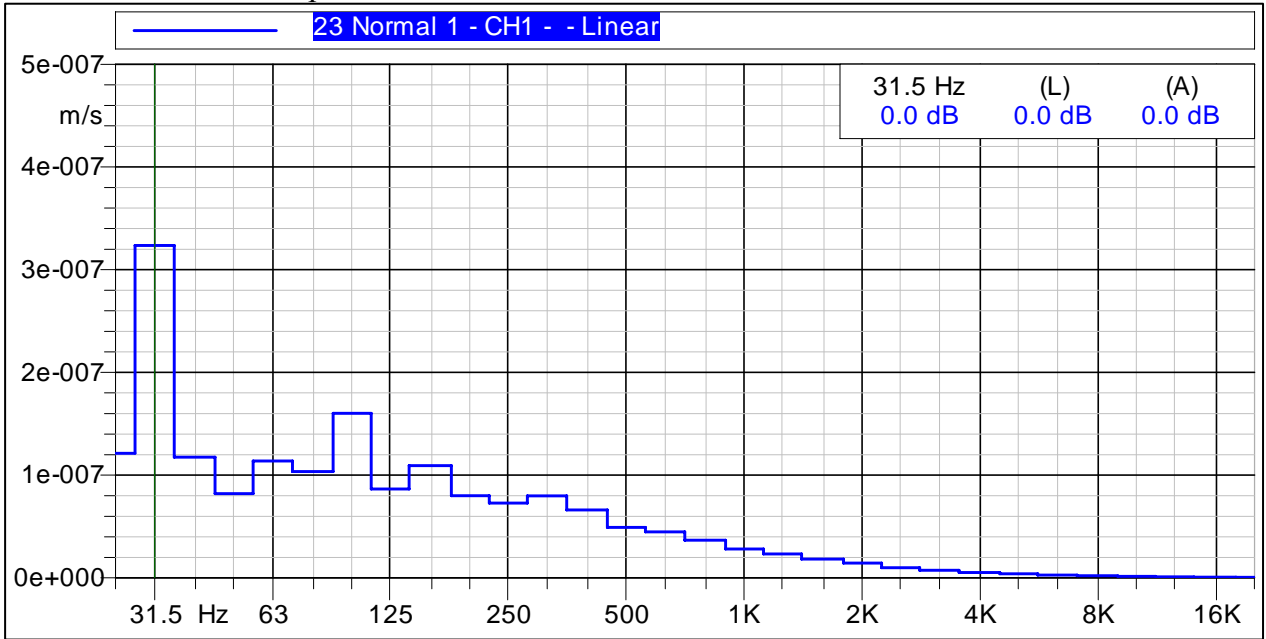
This figure shows that the maximum velocity occurred at 31.5 Hz. There is one large and one small frequency spikes that appear on this graph – the first at the octave band center of 31.5 Hz, the second at 100Hz.

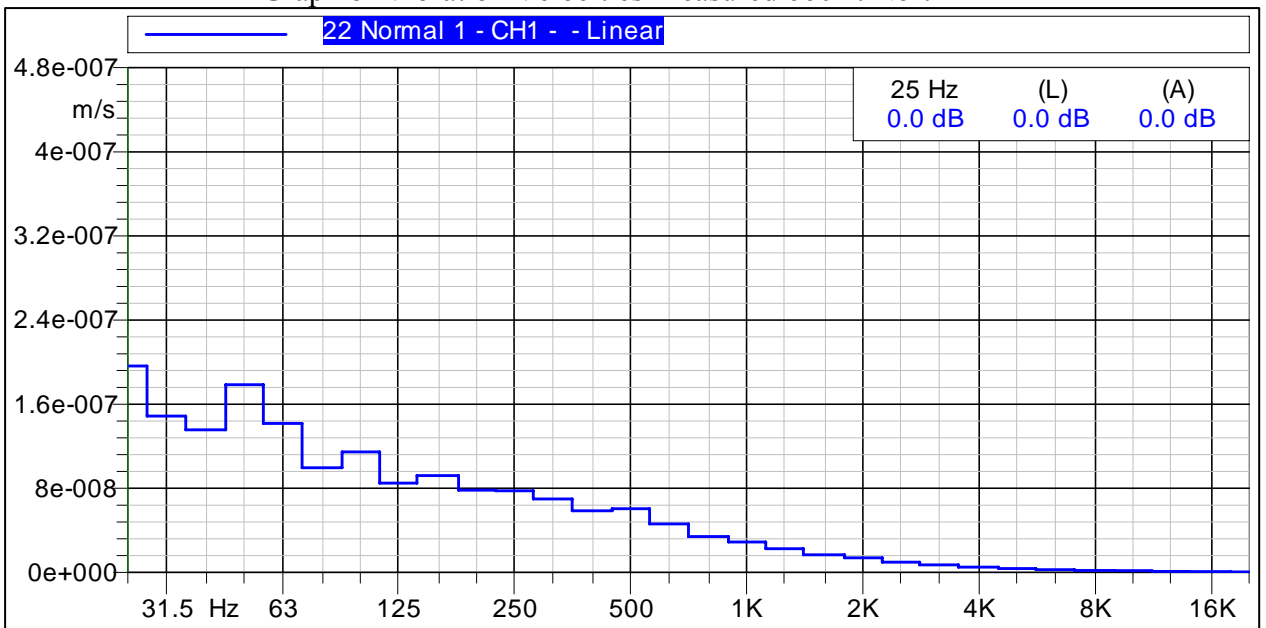
This figure shows that the maximum velocity occurred at 25 Hz. There are no frequency spikes that appear on this graph.
