Basin Electric Intertie Noise & Vibration Study and Land Use Assessment

September 2007

Executive Summary and Recommendations

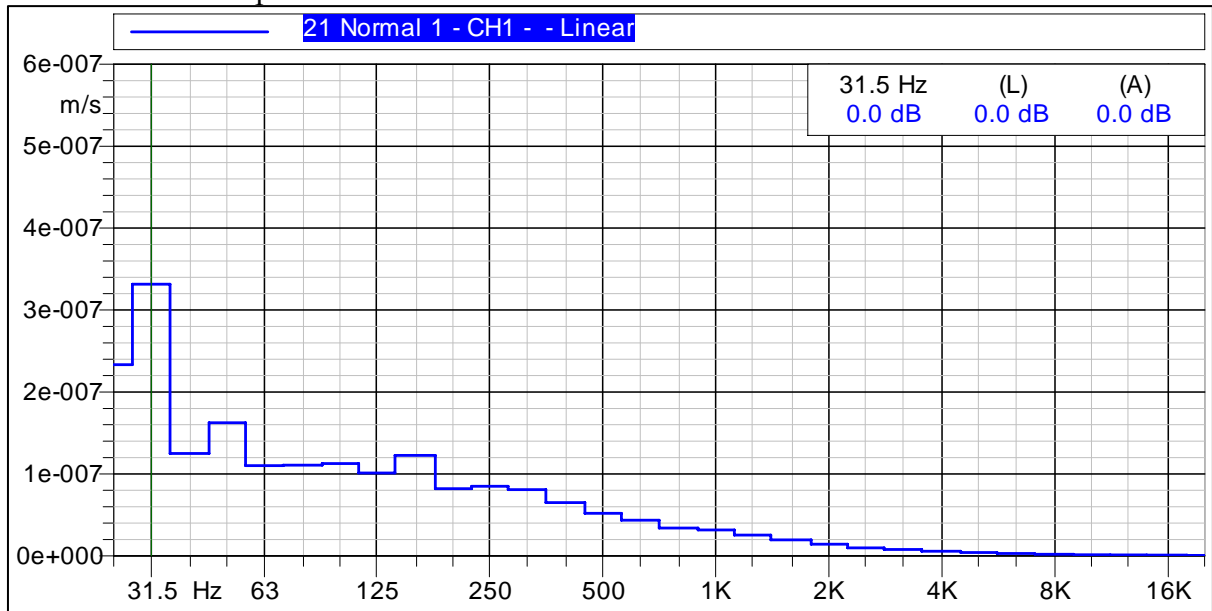
This figure shows that the maximum velocity occurred at 31.5 Hz. There is one frequency spike that appears on this graph – at the octave band center of 31.5 Hz.

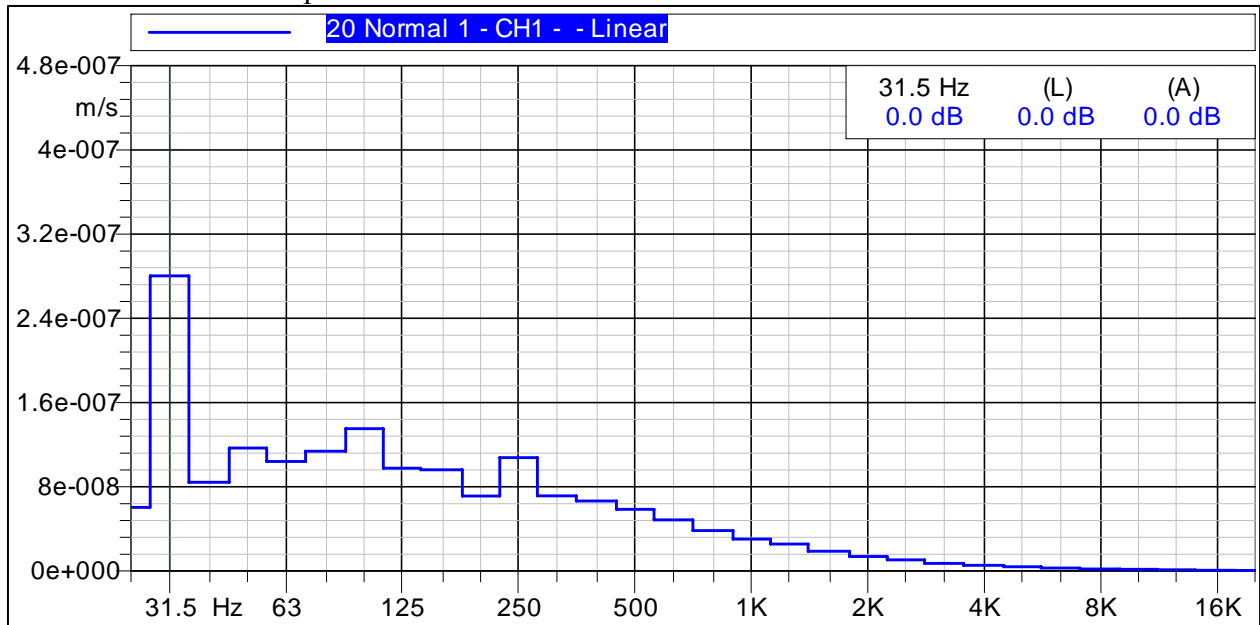
This figure shows that the maximum velocity occurred at 31.5 Hz. There is one frequency spike that appears on this graph – at the octave band center of 31.5 Hz.

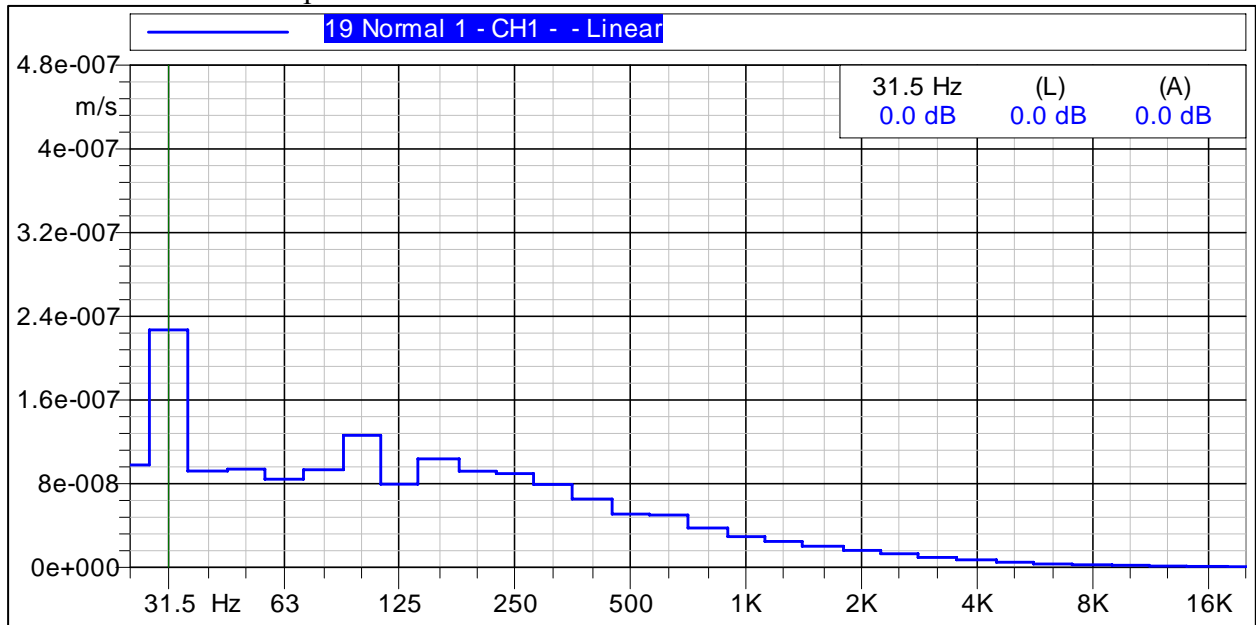
This figure shows that the maximum velocity occurred at 31.5 Hz. There is one large and one small frequency spikes that appear on this graph – the first at the octave band center of 31.5 Hz, the second at 100Hz.

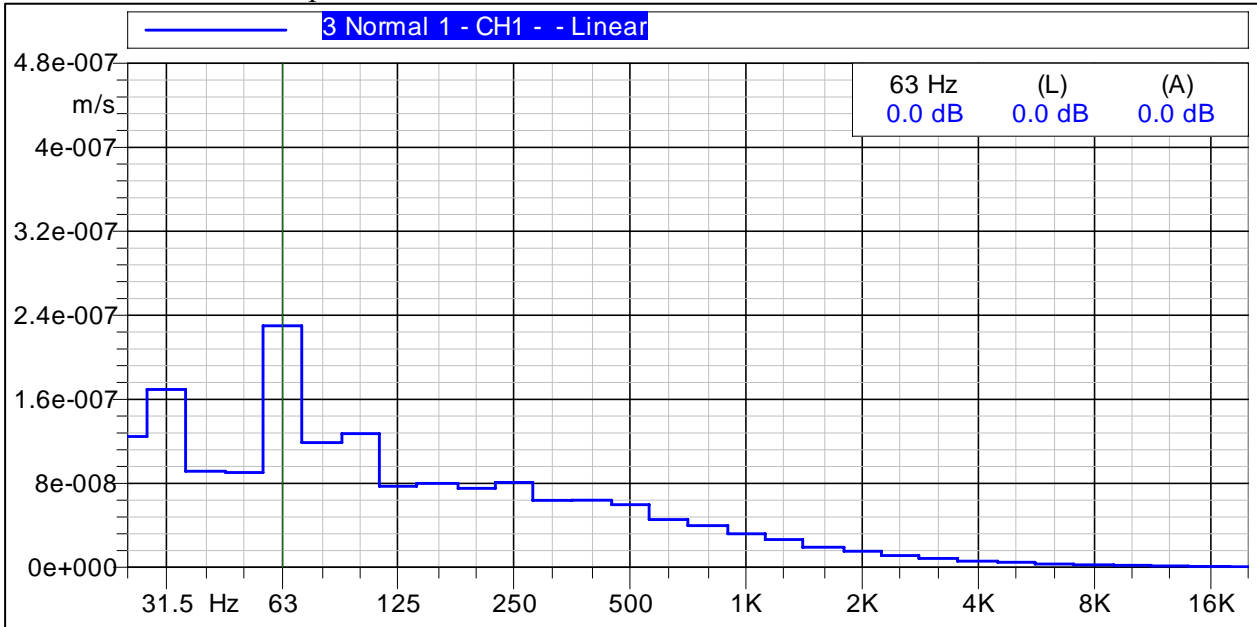
This figure shows that the maximum velocity occurred at 63 Hz. There is one large and one small frequency spike that appear on this graph – the first at the octave band center of 63 Hz, the second at the octave band center of 31.5Hz.

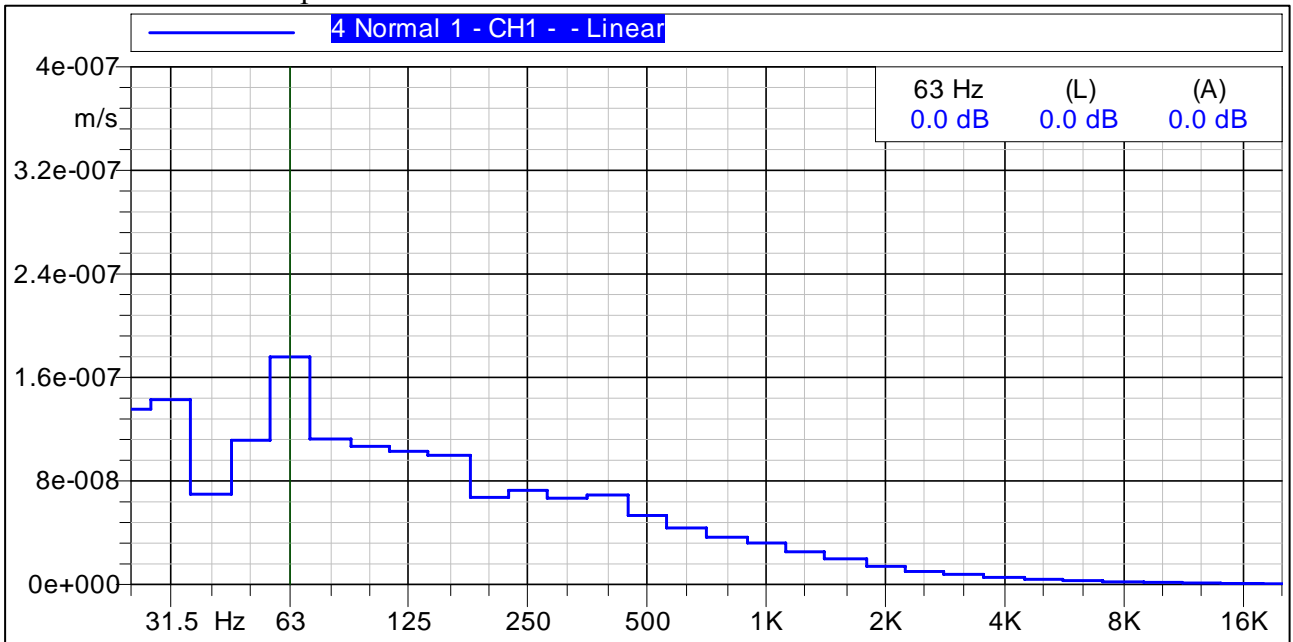
This figure shows that the maximum velocity occurred at 63 Hz. There is one frequency spike that appears on this graph – at the octave band center of 63 Hz.

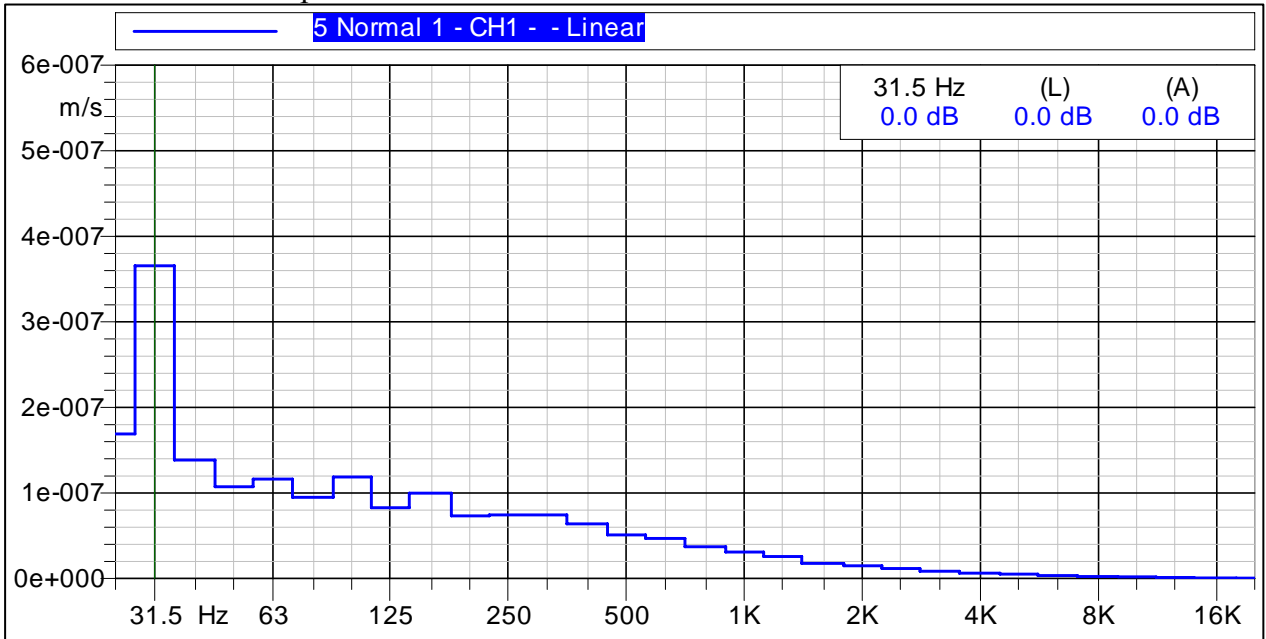
This figure shows that the maximum velocity occurred at 31.5 Hz. There is one frequency spike that appears on this graph – at the octave band center of 31.5 Hz.

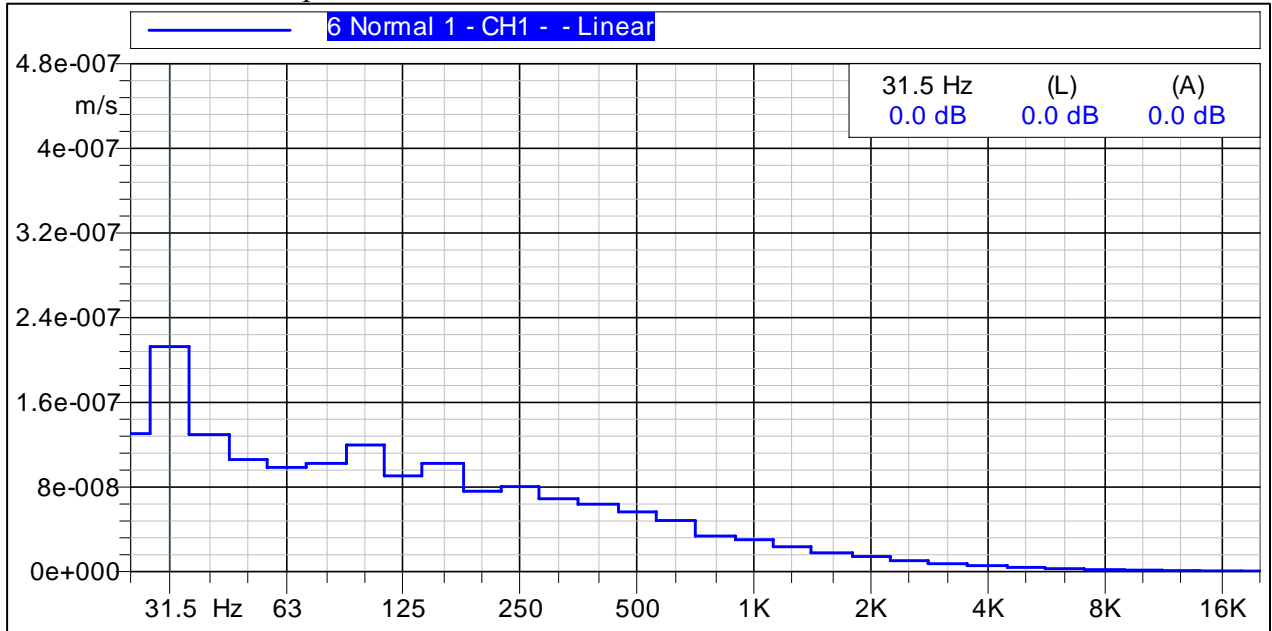
This figure shows that the maximum velocity occurred at 31.5 Hz. There is one frequency spike that appears on this graph – at the octave band center of 31.5 Hz.

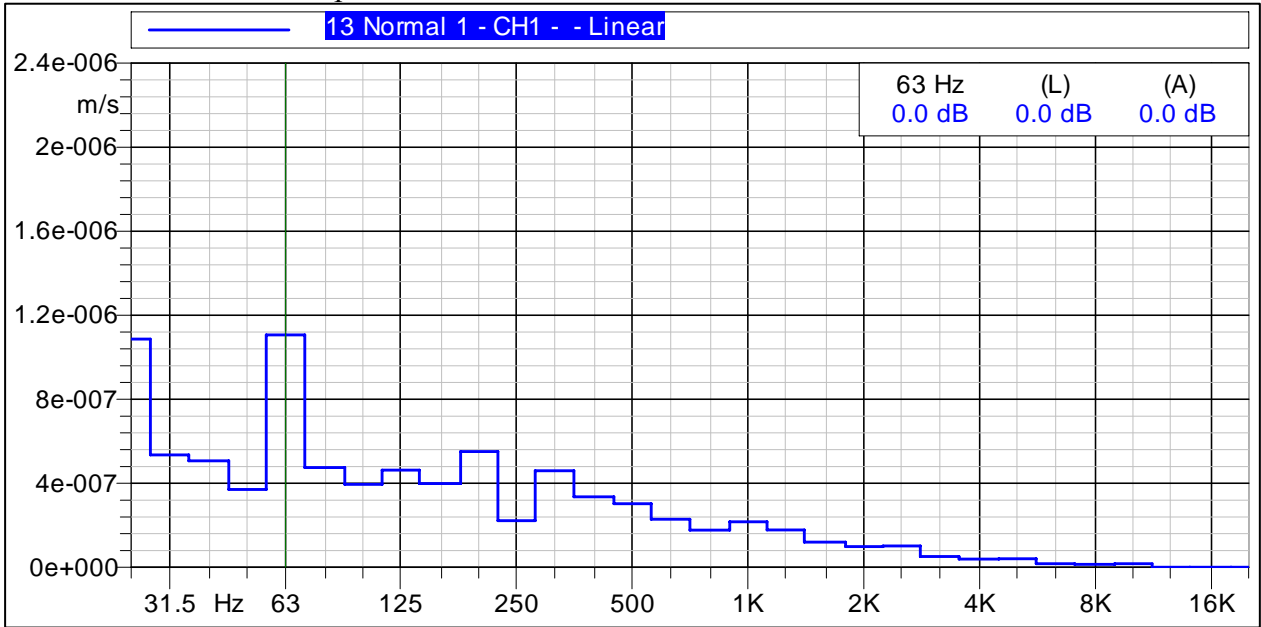
This figure shows that the maximum velocity occurred at 63 Hz. There are two large frequency spikes that appear on this graph – the first at the octave band center of 25 Hz, the second at the octave band center of 63Hz.

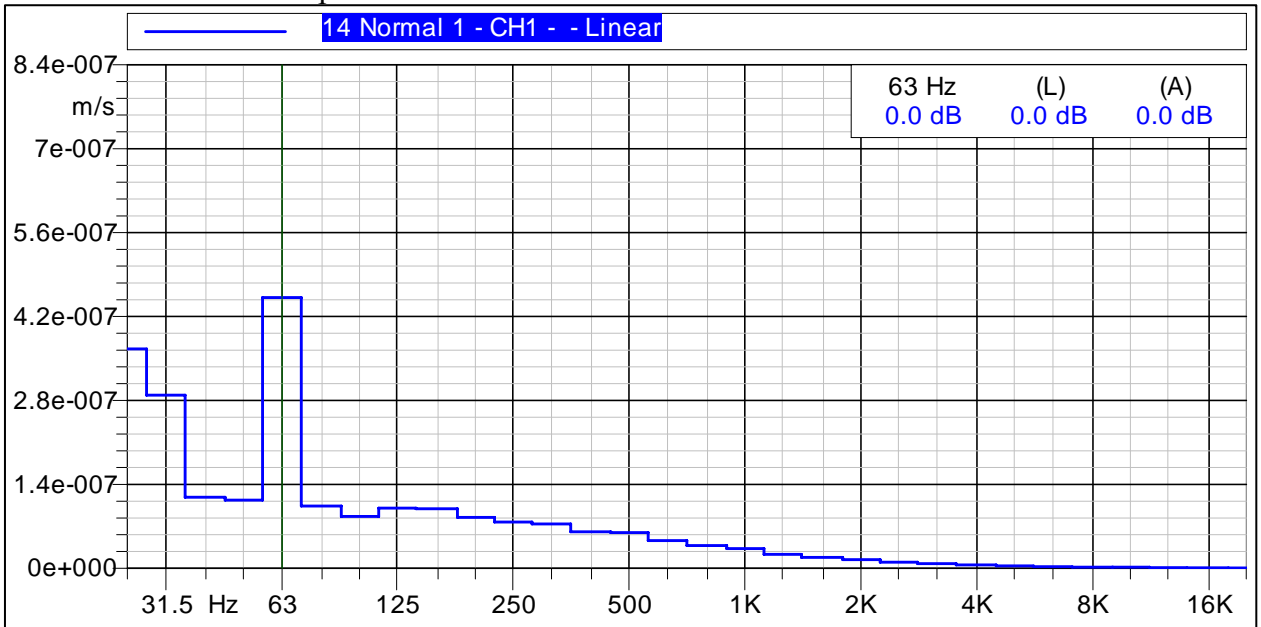
This figure shows that the maximum velocity occurred at 63 Hz. There are two large frequency spikes that appear on this graph – the first, a multi-frequency spike, centered at the octave band center of 25 Hz, the second at the octave band center of 63Hz.

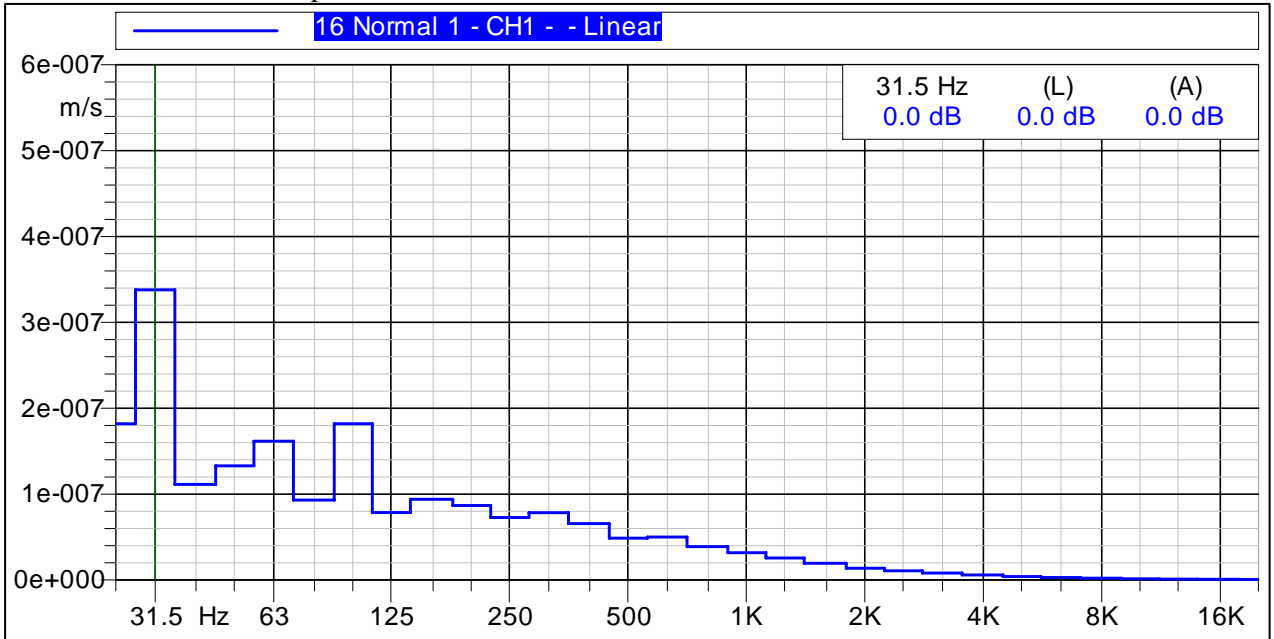
This figure shows that the maximum velocity occurred at 31.5 Hz. There is one large and one small frequency spike that appear on this graph – the first at the octave band center of 31.5 Hz, the second at 100 Hz.

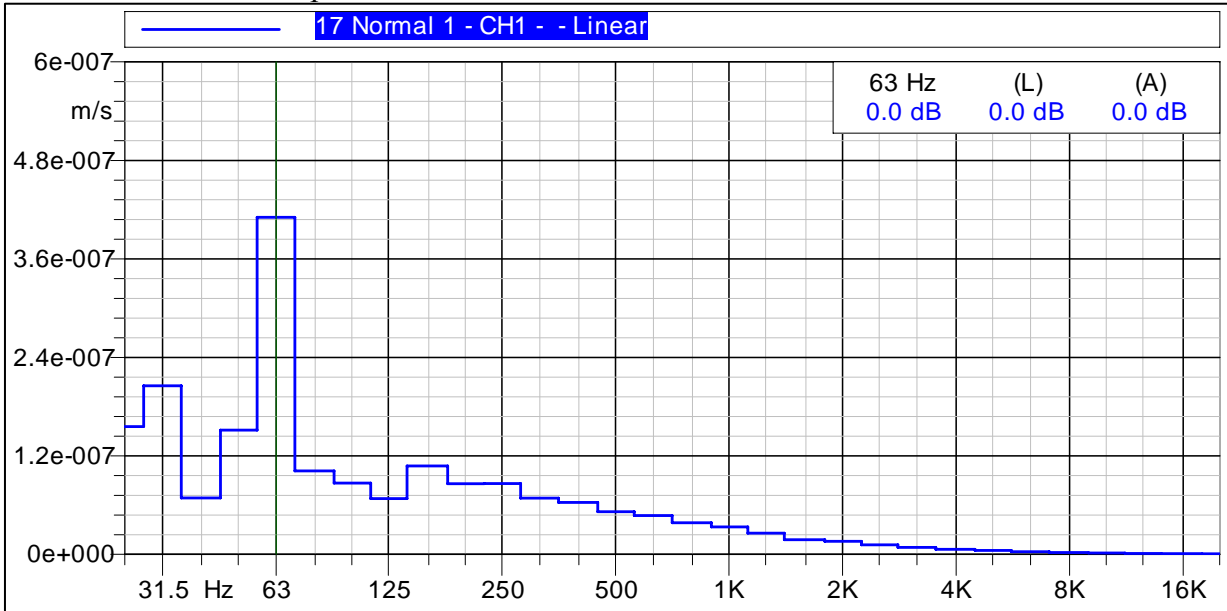
This figure shows that the maximum velocity occurred at 63 Hz. There is one large and one small frequency spike that appear on this graph – the first at the octave band center of 63 Hz, the second at the octave band center of 31.5 Hz.

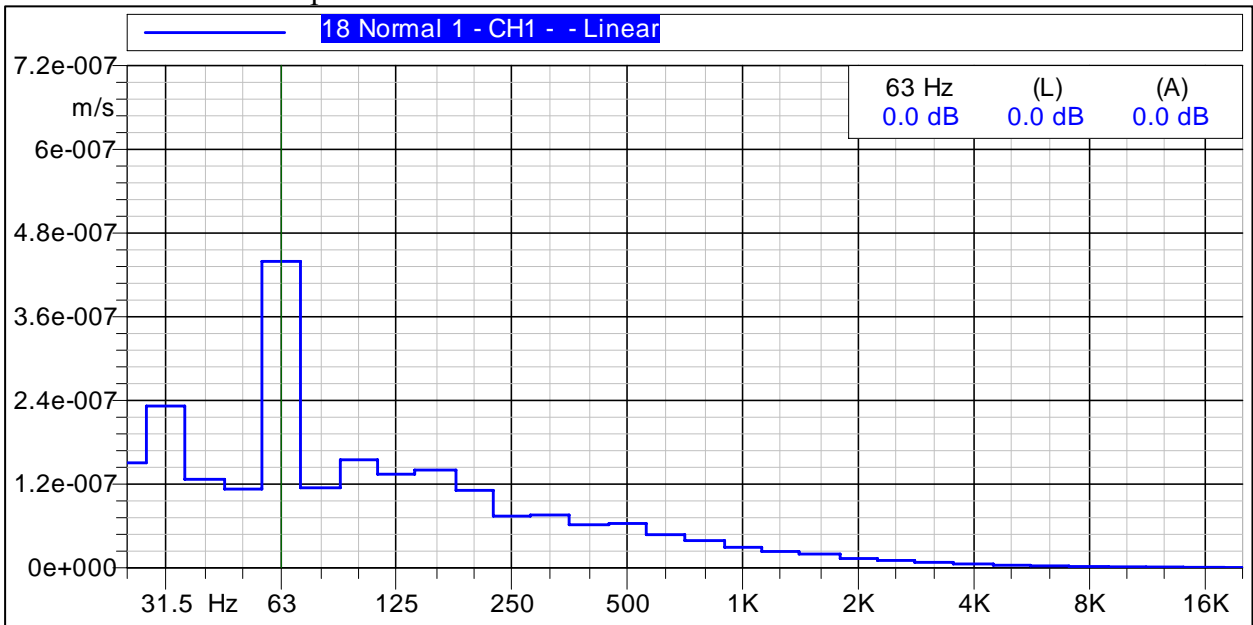
This figure shows that the maximum velocity occurred at 63 Hz. There is one large and one small frequency spike that appear on this graph – the first at the octave band center of 63 Hz, the second at the octave band center of 31.5 Hz.

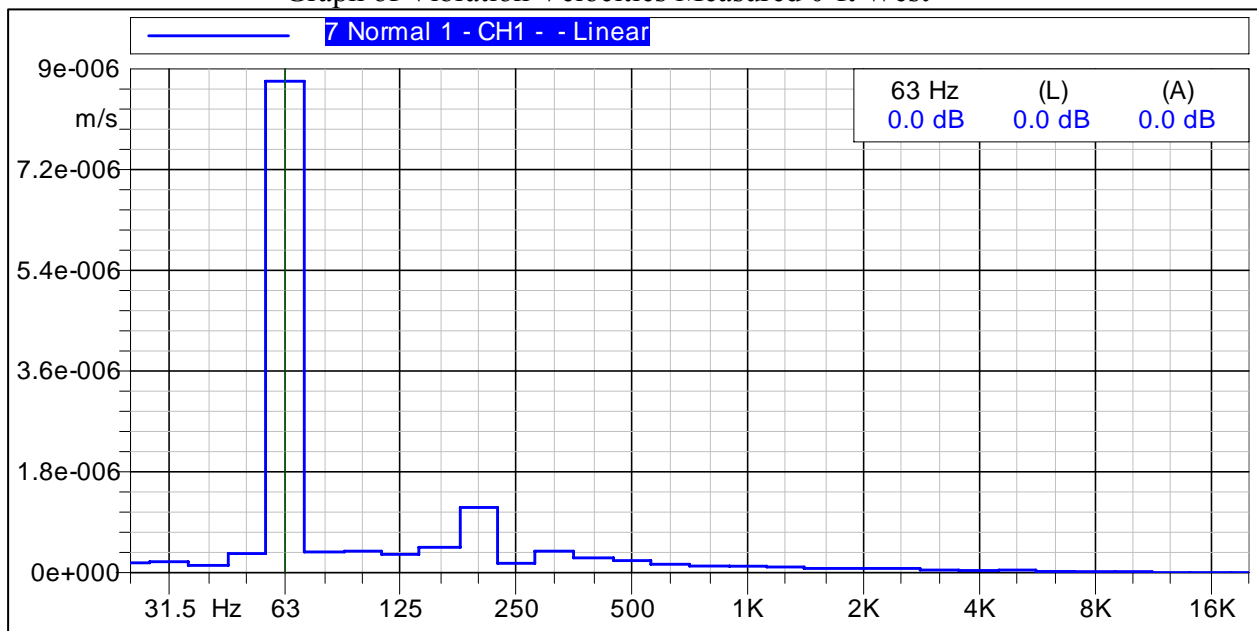
This figure shows that the maximum velocity occurred at 63 Hz. There is one large and one small frequency spike that appear on this graph – the first at the octave band center of 63 Hz, the second at 100 Hz.

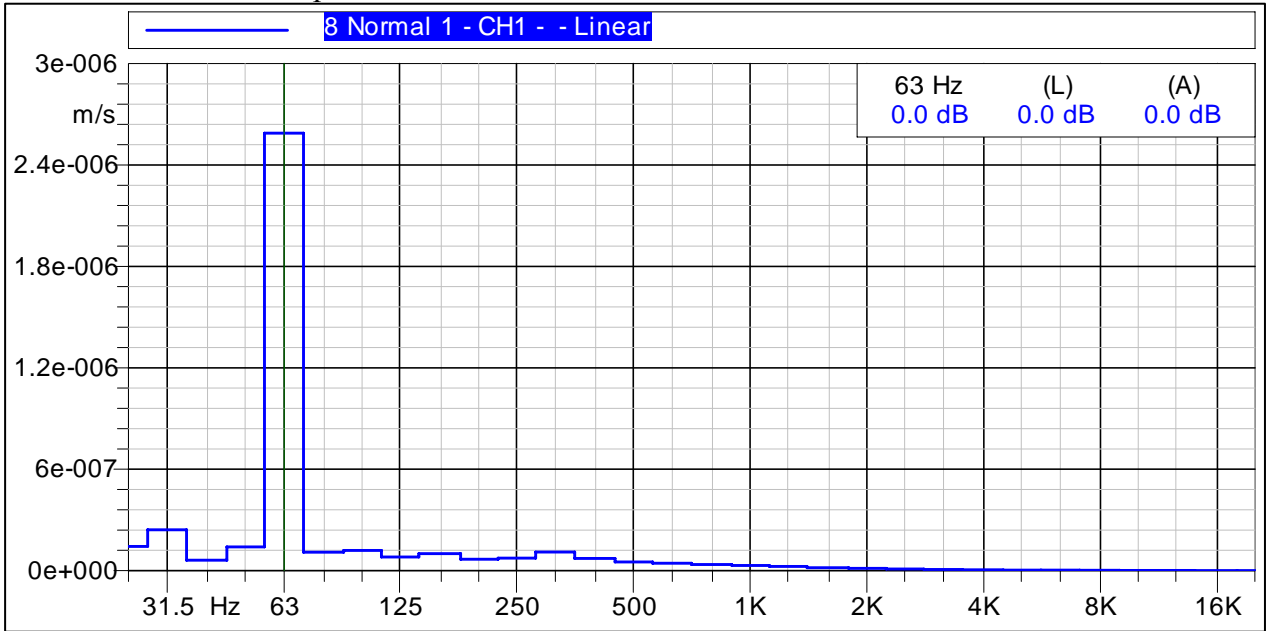
This figure shows that the maximum velocity occurred at 63Hz. There is one frequency spike that appears on this graph – at the octave band center of 63 Hz.

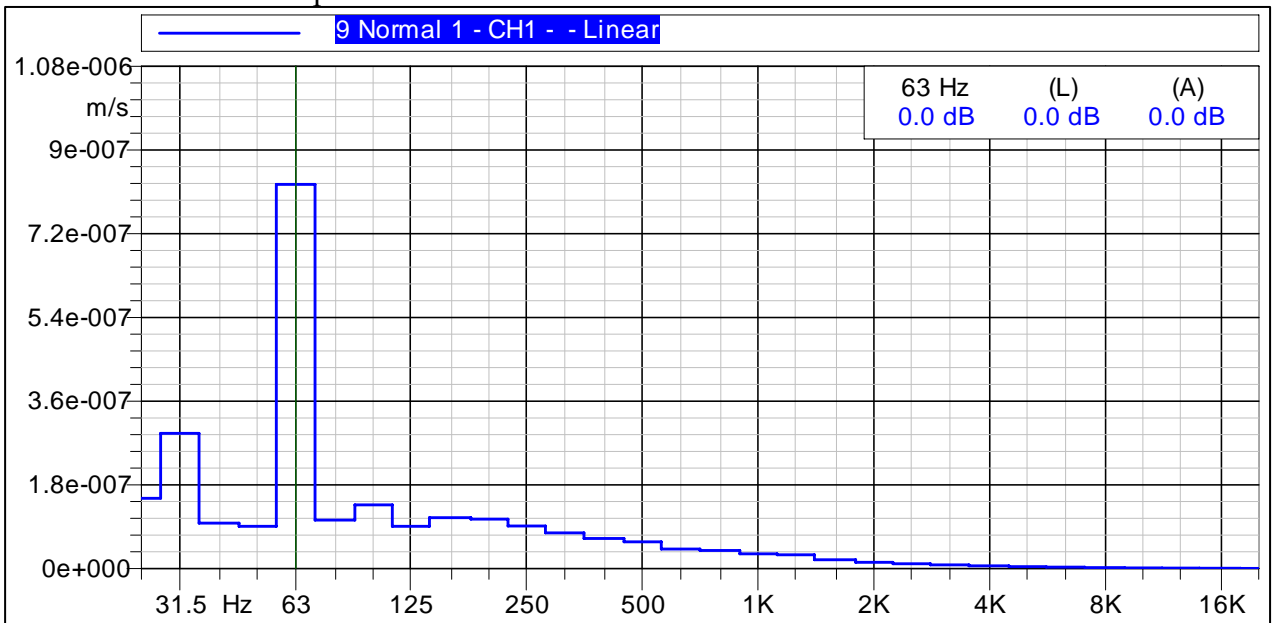
This figure shows that the maximum velocity occurred at 63 Hz. There is one large and one small frequency spike that appear on this graph – the first at the octave band center of 63 Hz, the second at the octave band center of 31.5 Hz.

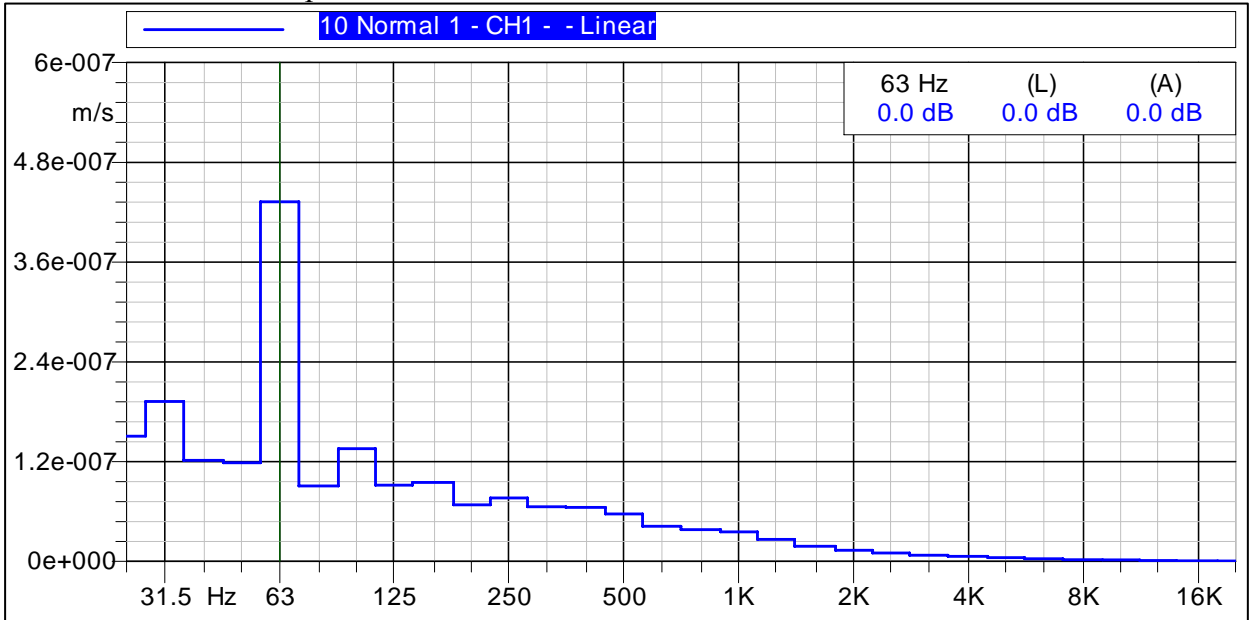
This figure shows that the maximum velocity occurred at 63 Hz. There is one large and one small frequency spike that appear on this graph – the first at the octave band center of 63 Hz, the second at the octave band center of 31.5 Hz.

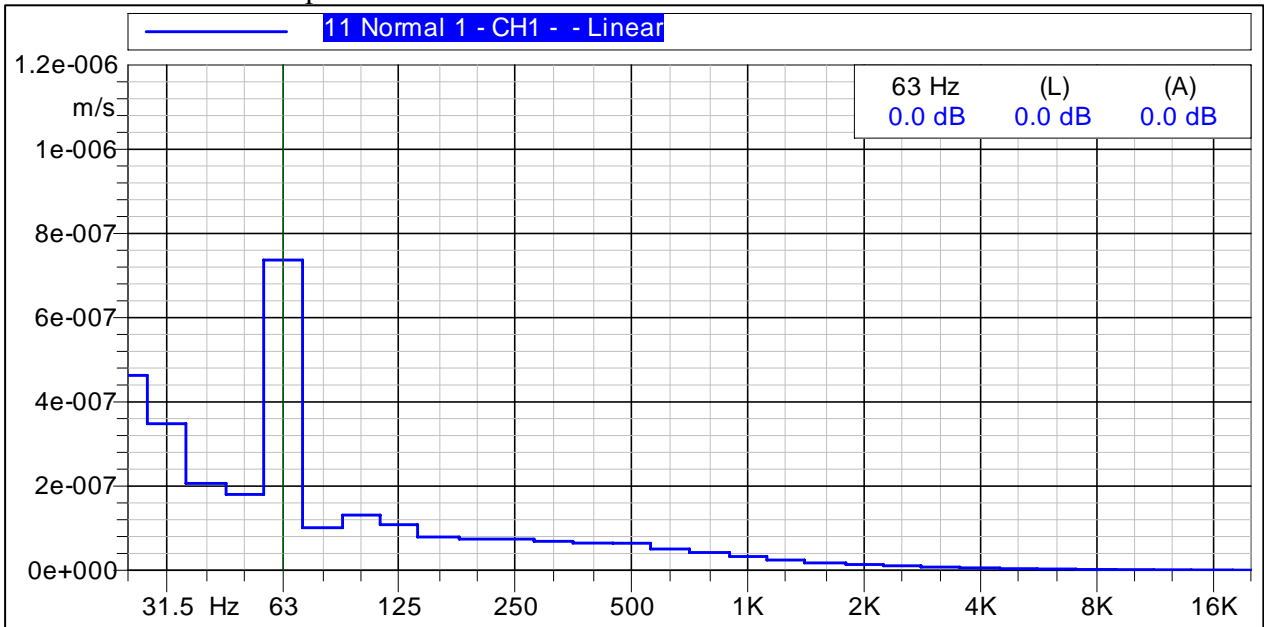
This figure shows that the maximum velocity occurred at 63Hz. There is one frequency spike that appears on this graph – at the octave band center of 63 Hz.

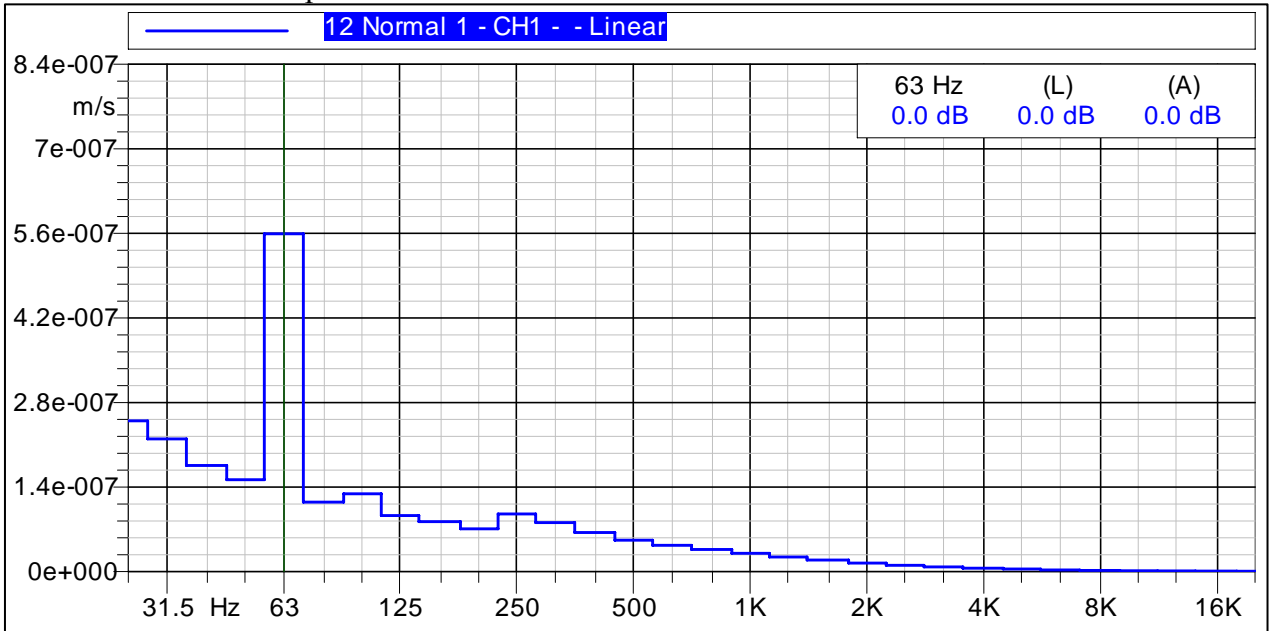
This figure shows that the maximum velocity occurred at 63Hz. There is one frequency spike that appears on this graph – at the octave band center of 63 Hz.
